## **C.7 Summary reports**

### C.7.2 Reports

Reference & Chainage <sup>1</sup>	<b>RS1</b> <b>0.000-0.125</b>	Location	OS NGR 387585,785681
Date of Inspection	7 April 2010	Inspector(s)	Stephen Farrar
Nature of Inspection	Visual	Nature of Assets	Rock Revetment
Model cross section showing peak 0.5% AP (200 year) event water level

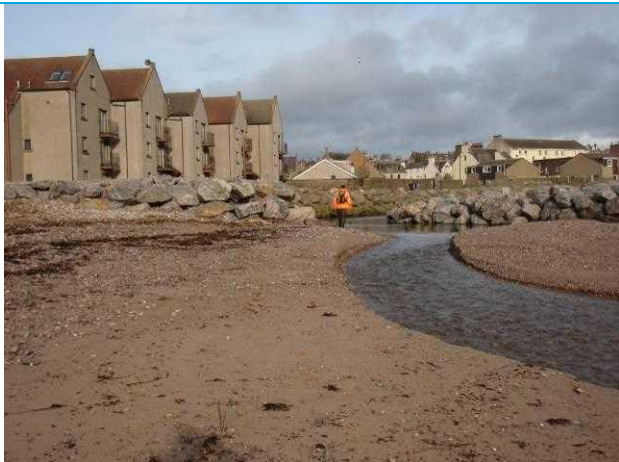
Photograph 1: View Looking Upstream	Photograph 2: View Looking Downstream

Description	Rock Revetment provided placed to prevent route of river channel changing, on beach near housing. Embankment approx. 2m high.		
Anticipated Ground Conditions	Loose Sand.		
Potential Ground Investigation	Type	SPT's	
	Access	Good	
Structural comments	The stones were angular and reasonably well packed. There is no major evidence of settlement or movement in stone. Although it was unclear whether any measures had been taken to prevent fines washing out from behind the stones, it is possible larger stones placed over shingle.

Design considerations	It is unlikely that any work is required at this point, as this element is not restricting channel capacity.		
General condition	Condition of revetment is good.		
Remedial action required	None

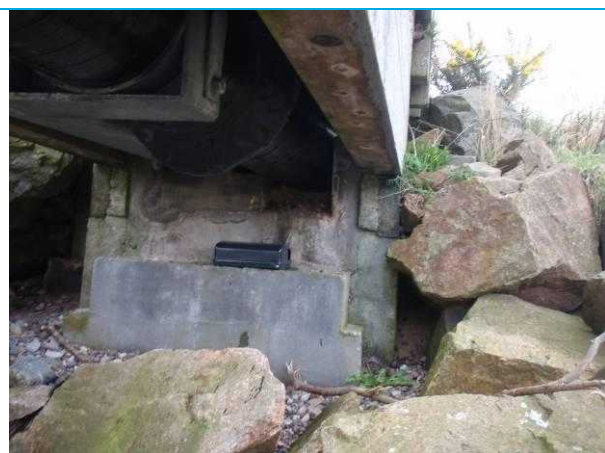
Photograph 3: RHB Abutment, note evidence of previous bridge, below existing beams.

Description	Stressed laminated timber footbridge made of tropical hardwood, fixed together with stainless steel bolts, with mass concrete abutments. It would appear to be a replacement for a previous footbridge, the ends of whose beams remain in the abutments, which have been reused.	
Anticipated Ground Conditions	Loose Sand/Shingle.	
Potential Ground Investigation	Type	SPT's
	Access	Good
Structural comments	There were no major signs of deterioration, although the bearing detail could act as a moisture trap leading to rot. However the timber species used is likely to be durable or very durable.	
Design considerations	Although the beam ends appear partially built in, it should be possible to break out the surrounding concrete to raise the bridge if required.	
General condition	The bridge was in very good condition.	
Remedial action required	None

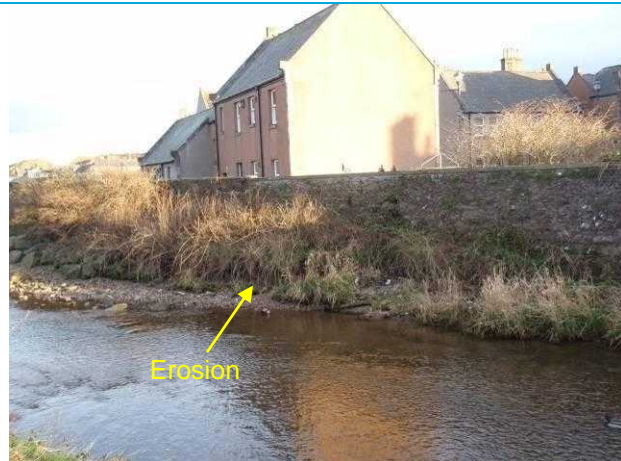
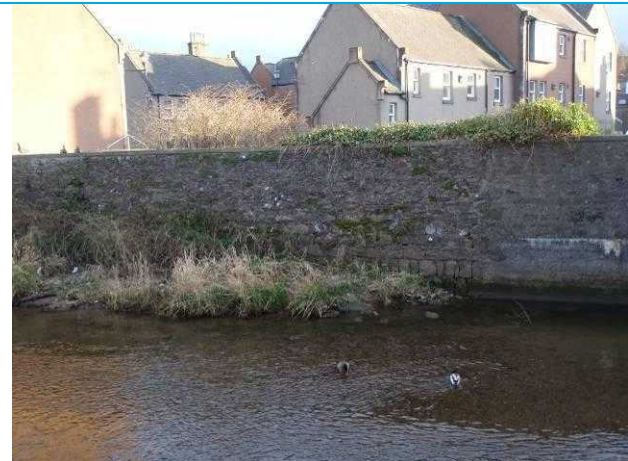
Photograph 3: View of wall looking upstream, note local erosion.

Photograph 4: Western end of wall, note local erosion.

Description	Random rubble stone wall, founded on embankment with splayed foundation.	
Anticipated Ground Conditions	Sand & Gravels.	
Potential Ground Investigation	Type	Hand Dug Trial Pits behind/in front of wall to establish depth of footings. In situ SPT's, Soil grading tests.
	Access	Good along beach. Through walled garden along river.
Structural comments	Wall showed no sign of major structural movement. The wall looks well constructed and would appear to date from a similar period to the older houses, possibly late 19th Century or early 20th Century. Given its age it is in good condition, although much of the pointing was loose or missing. It was also affected by the growth of vegetation in some areas.	
Design considerations		
General condition	The overall condition of wall and embankment is considered fair, although there is the possibility of this deteriorating quite rapidly to poor if no maintenance carried out.

Remedial action required	The wall will need repointing preferably in a lime based mortar, to match original materials, by suitably qualified craftsmen. Action should be taken to slow erosion at the toe of the embankment.

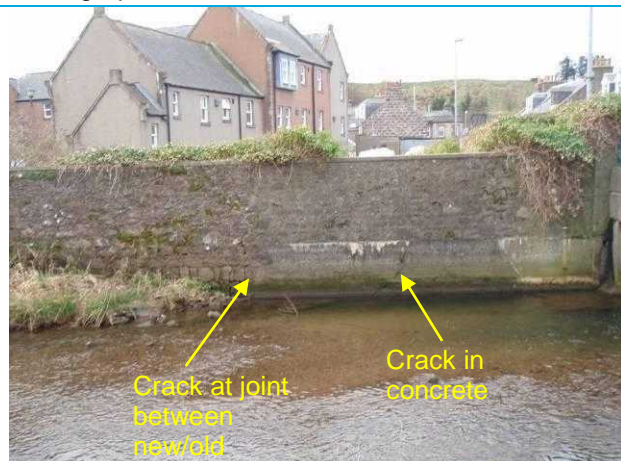
Photograph 1: View of wall,

Description	Modern random rubble stone wall, founded on mass concrete base.	
Anticipated Ground Conditions	Sand & Gravels.	
Potential Ground Investigation	Type	In situ SPT's, Soil grading
	Access	Access through walled garden, possibly accessible for terrier rig.
Structural comments	Wall showed no sign of major structural movement. The wall looks well constructed and would appear to date from when the bridge was constructed in the 1970's. Pointing is in reasonable condition. There is a crack where new and old construction meets, and a diagonal crack in the mass concrete, but this is limited in extent. It is not known how far the footings extend into the river bed.	
Design considerations		
General condition	The overall condition of wall and embankment is considered good, although there is the possibility of this deteriorating if no maintenance carried out.	
Remedial action required	The wall will need repointing preferably to match original materials, by suitably qualified craftsmen. An assessment of the likelihood of and depth of scour should be undertaken to ensure the wall is not undermined.

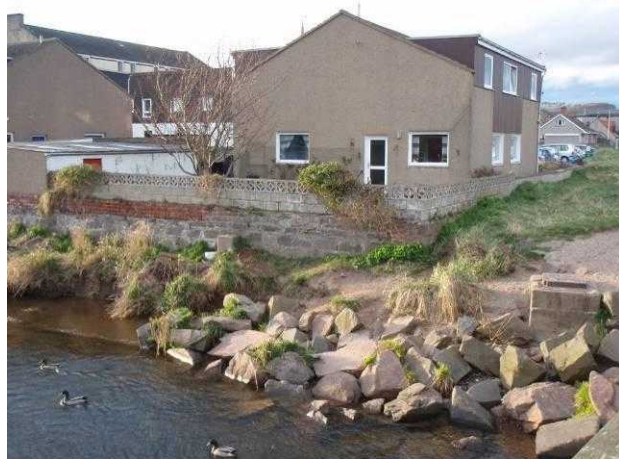
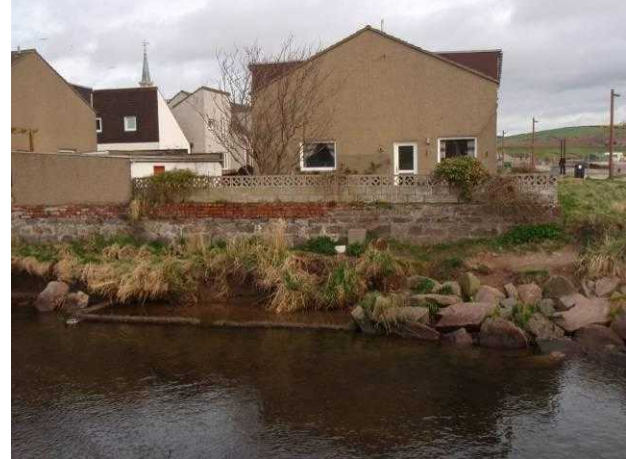
Photograph 1: Single skin masonry wall, on stone wall. Note rock armouring and erosion below.

Photograph 2: View as Photograph 1, from different angle.

Description	Traditional stone built wall, raised with brick and blockwork	
Anticipated Ground Conditions	Sand & Gravels.	
Potential Ground Investigation	Type	In situ SPT's, Soil grading
	Access	Access through walled garden, possibly accessible for terrier rig.
Structural comments	Wall shows no sign of major structural movement although the newer raised wall is poorly constructed. There are signs of erosion at the base.	
Design considerations	The wall in its current state is liable to collapse under flood conditions.	
General condition	The overall condition is considered poor, due to possibility of erosion at base.	
Remedial action required	Some form of bank protection will be required, lower part of wall will require repointing to match original materials, and top of garden wall rebuilt.

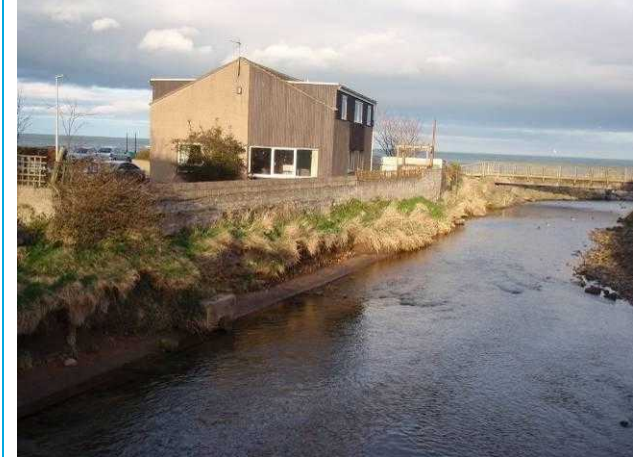
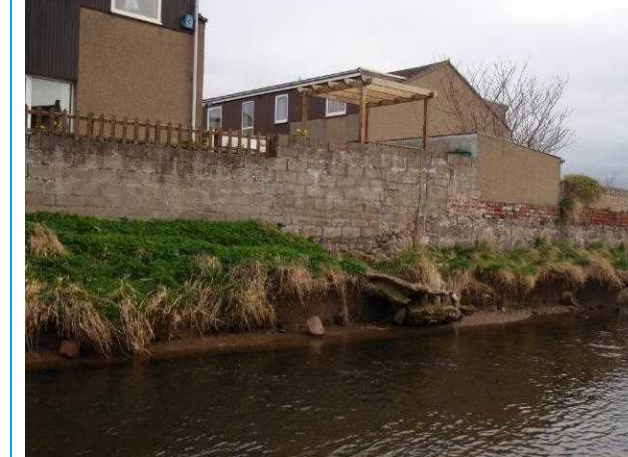
Photograph 1: View along blockwork wall.

Photograph 2: Single skin blockwork wall built off older wall, wall shows some sign of minor cracking at joints.

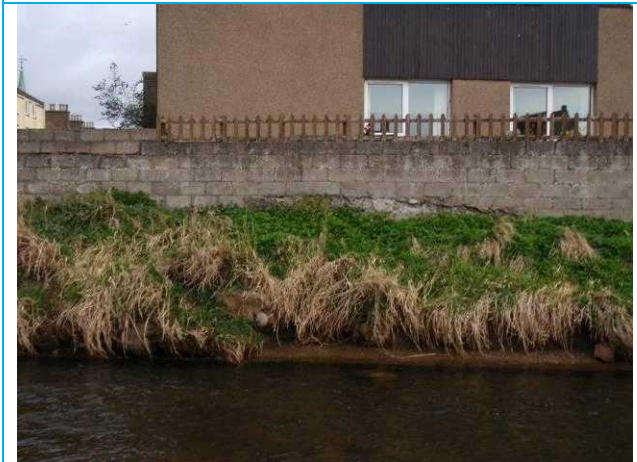
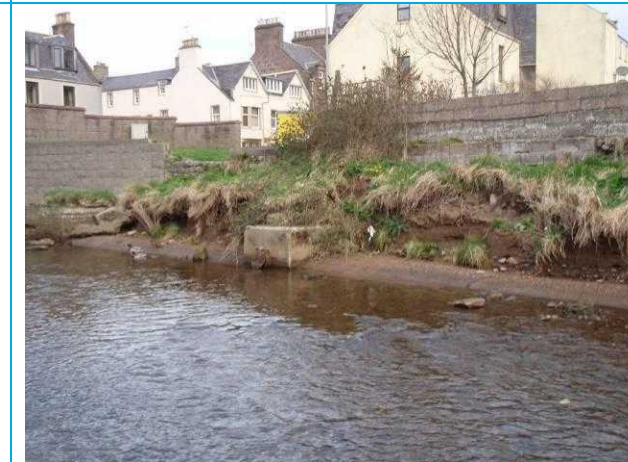
Photograph 3: Note cracking where wall built on older footings.

Photograph 4: Upstream end of wall, note erosion at base.

Description	Blockwork wall built off older stone footings.	
Anticipated Ground Conditions	Sand & Gravels.	
Potential Ground Investigation	Type	In situ SPT's, Soil grading
	Access	Good access through private driveway.
Structural comments	Wall shows signs of structural movement, due to earth pressure behind wall. Wall is poorly constructed. There are signs of erosion at the base.	
Design considerations	The wall in its current state is liable to collapse under flood conditions.	
General condition	The overall condition is considered poor, due to erosion at base.	
Remedial action required	Some form of bank protection will be required; wall is likely to require rebuilding.

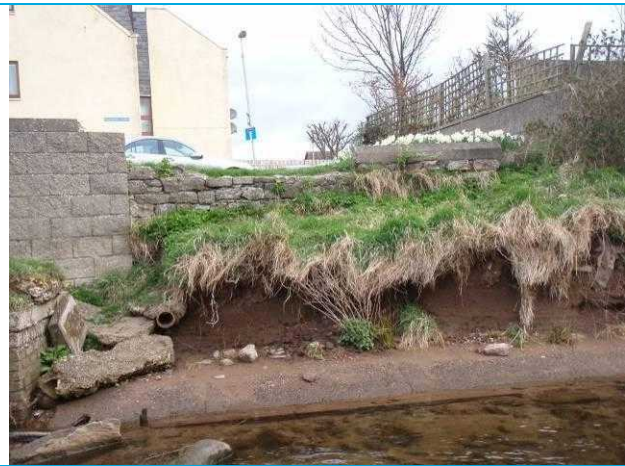
Photograph 1: Stone Wall.

Description	Stone Wall	
Anticipated Ground Conditions	Sand & Gravels.	
Potential Ground Investigation	Type	In situ SPT's, Soil grading
	Access	Good
Structural comments	Wall in poor condition, top stones already collapsed, bank undergoing erosion.	
Design considerations	Wall likely to collapse further.	
General condition	Very poor, partial collapse already occurred	
Remedial action required	New wall required with erosion protection.

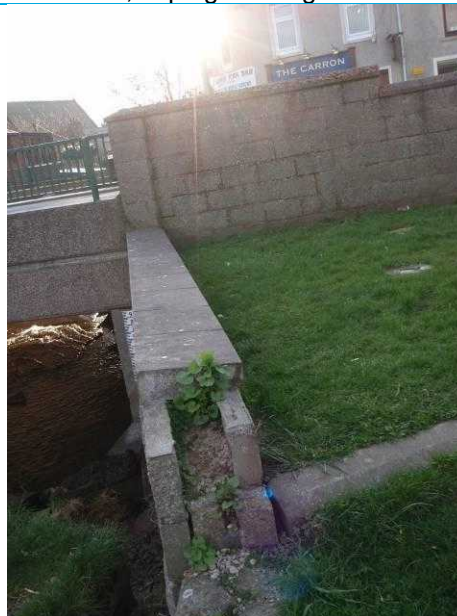
Photograph 2: Some delamination of outerskin of blockwork, coping missing.

Description	Reinforced blockwork wing wall on concrete footing.	
Anticipated Ground Conditions	Sand & Gravels.	
Potential Ground Investigation	Type	In situ SPT's, Soil grading
	Access	Access through walled garden, possibly accessible for terrier rig.
Structural comments	No major signs of structural movement, some deterioration to top of wall. Depth of foundations not known, although it is likely that a scour assessment has been carried out by the council, as sheet piling toe protection has been installed on the other side.	
Design considerations		
General condition	Very Good	
Remedial action required	Minor repairs to top of wall.

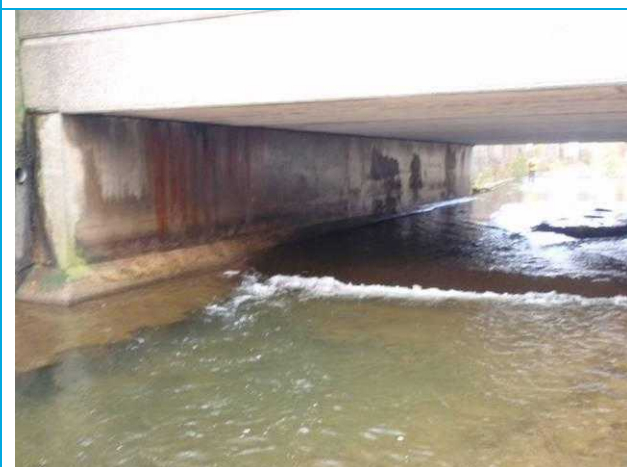
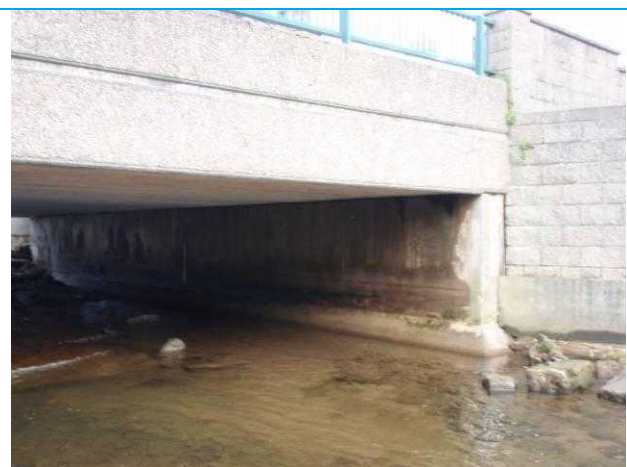
Photograph 3: RHB abutment, note sheet piling to protect toe.

Photograph 4: LHB abutment.

Description	Bridge, composed of precast concrete beams on concrete abutments, with concrete skirt (partially intact) and sheet pile toe protection.	
Anticipated Ground Conditions	Sand & Gravels.	
Potential Ground Investigation	Type	N/A
	Access	Good, although services present, and road closure likely to be required. Council likely to have records relating to the construction of the original bridge.
Structural comments	The bridge is generally in good condition. There are some signs of structural movement in a wing wall, probably due to the foundations being shallower than those of the main bridge structure. However the wing wall is not significant in terms of retaining water in the river channel.	
Design considerations	The bridge may be restricting flow through the river channel. It may be possible to raise the bridge, by freeing its ends, jacking it up and building up the abutments. Road surfacing and services etc will need to be relaid over the top. This operation is likely to be extremely disruptive.

General condition	Good	
Remedial action required	None.

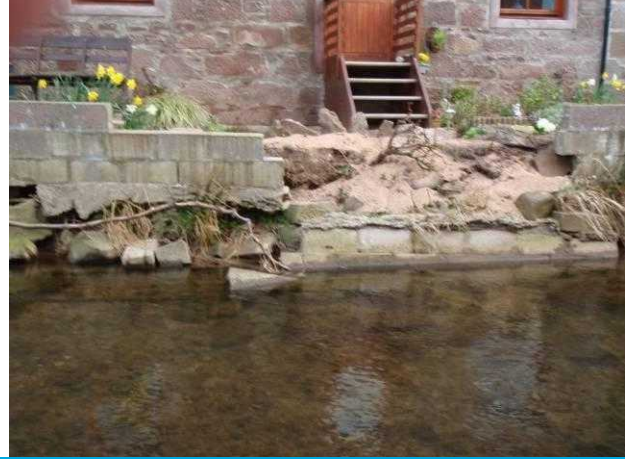
Photograph 3: Upstream end of wall showing collapse of section (believed to have occurred during November 2009 flood event).

Description	Single skin blockwork wall on edge of river channel.	
Anticipated Ground Conditions	Sand & Gravels.	
Potential Ground Investigation	Type	In situ SPT's, Soil grading
	Access	Access limited to hand tools. A rig could be lifted with crane from bridge.
Structural comments	Wall partially collapsed large areas of the river bank below footings eroded.	
Environmental considerations		
Design considerations	The wall is not providing any protection to the property to the rear.	
General condition	Very Poor.	
Remedial action required	Toe protection, combined with new wall required, or new wall with sufficiently deep footings required.

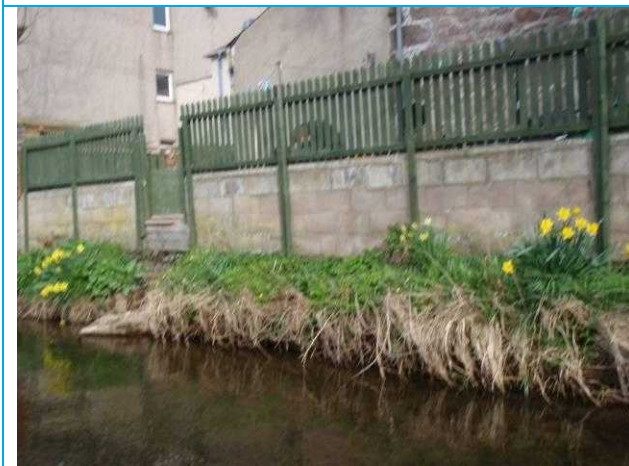
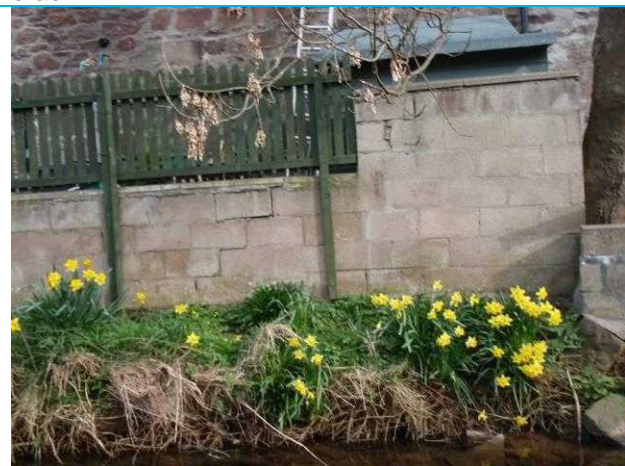
Photograph 2: View of wall.

Photograph 1: View of wall, showing diagonal crack.

Description	Single skin blockwork wall with timber paling on top.	
Anticipated Ground Conditions	Sand & Gravels.	
Potential Ground Investigation	Type	In situ SPT's, Soil grading
	Access	Access restricted to hand tools.
Structural comments	The wall shows some signs of settlement and the bank is being eroded. It is poorly constructed.	
Design considerations	This wall is likely to collapse under flood conditions	
General condition	Poor	
Remedial action required	Toe protection, combined with new wall required, or new wall with sufficiently deep footings required.

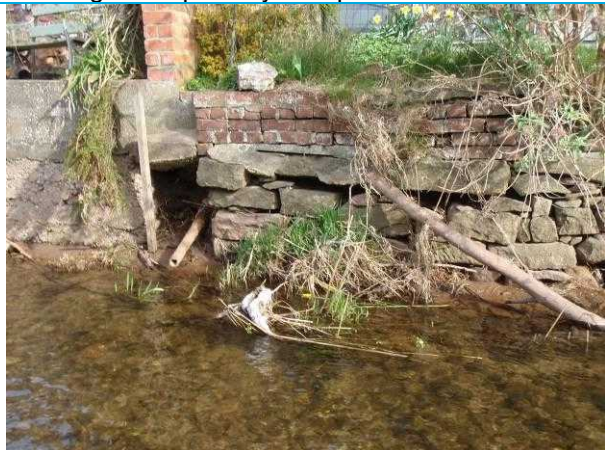
Photograph 1: View of upstream end of wall, showing loose/partially collapsed stones.

Description	Stone wall extended with brickwork at upstream end.	
Anticipated Ground Conditions	Sand & Gravels.	
Potential Ground Investigation	Type	In situ SPT's, Soil grading
	Access	Access through walled garden, possibly accessible for terrier rig.
Structural comments	This wall appears to be gradually collapsing into the river. However, due to the size of stones used they are still proving some protection to the toe of the bank.	
Design considerations	The wall would not provide any protection from flooding.	
General condition	Poor	
Remedial action required	Toe protection, combined with new wall required, or new wall with sufficiently deep footings required.

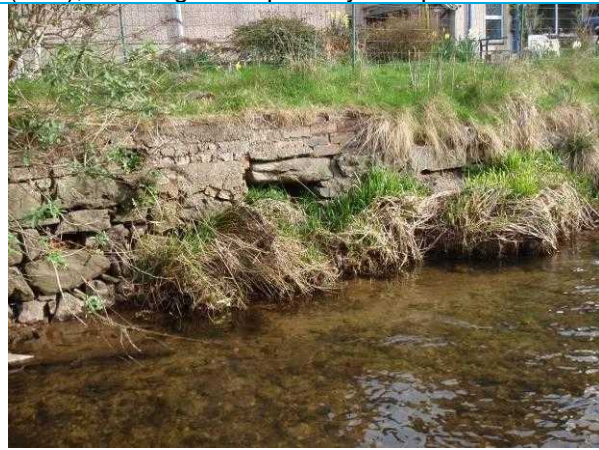
Photograph 2: View of upstream end of wall (cont), showing loose/partially collapsed stones.

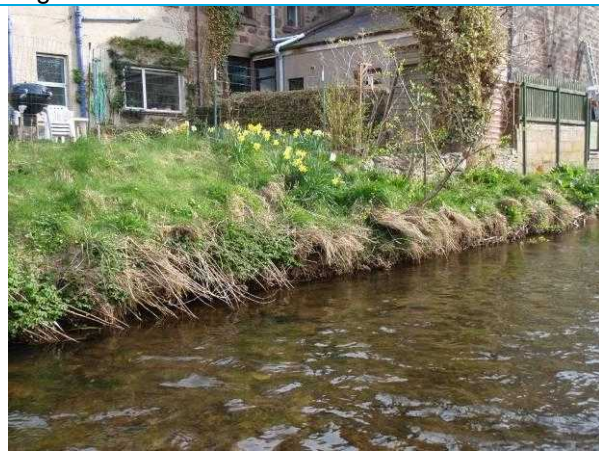
Photograph 4: View of downstream end of wall, wall possibly partially collapsed and bank vegetated.

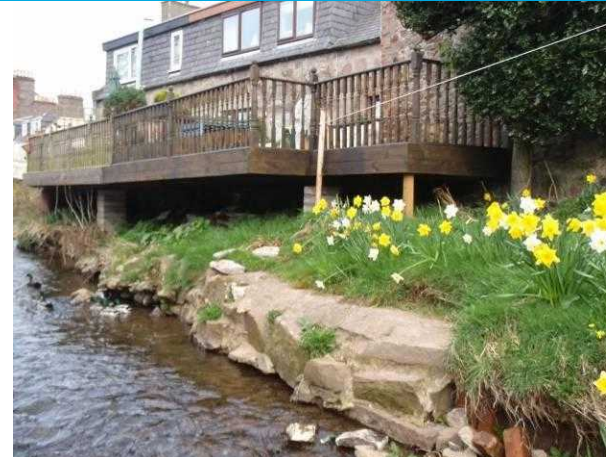
Photograph 2: Random stones providing small degree edge protection.

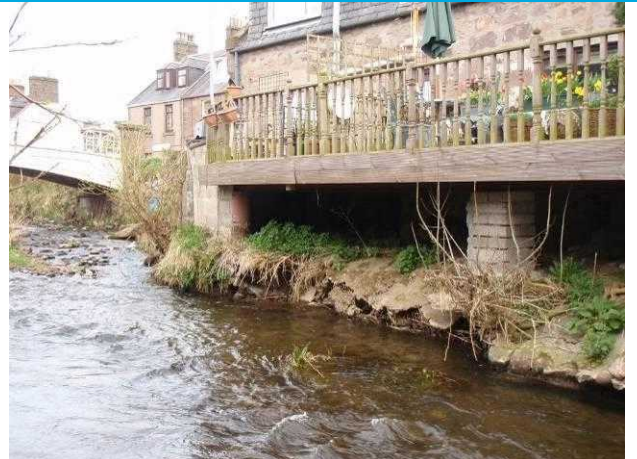
Photograph 3: Foundations to pier supporting decking being undermined.

Description	Assorted walls and bank protection.	
Anticipated Ground Conditions	Sand & Gravels.	
Potential Ground Investigation	Type	In situ SPT's, Soil grading.
	Access	Access through walled garden, possibly accessible for terrier rig.
Structural comments	River bank is being eroded, despite 'nominal' edge protection. The timber decking is likely to collapse in a flood. The upstream sections of wall look stable at present, although the depth of foundations is not known.	
Design considerations		
General condition	Poor	
Remedial action required	The upstream sections of wall may require toe protection and repointing. Elsewhere toe protection, combined with new/strengthened wall will be required.

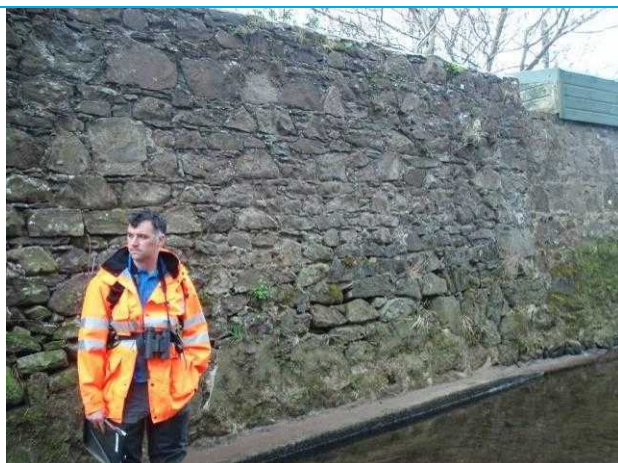
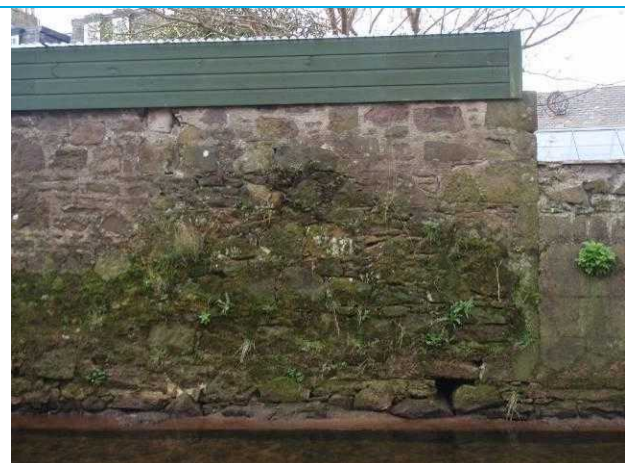
Photograph 3: View of wall showing open joints.

Photograph 4: View of wall showing moss, vegetation and open joints.

Description	Traditionally built random rubble stone wall, comprising variety of different sections.	
Anticipated Ground Conditions	Sand & Gravels.	
Potential Ground Investigation	Type	In situ SPT's, Soil grading
	Access	Access through walled garden, possibly accessible for terrier rig.
Structural comments	There were no signs of significant structural movement. Toe protection was generally present and intact, although the depth of this is not known. There were areas of loose stone, and open joints.	
Design considerations		
General condition	The general condition of the wall is considered fair.	
Remedial action required	Consolidation and repointing of stonework in materials to match original construction.

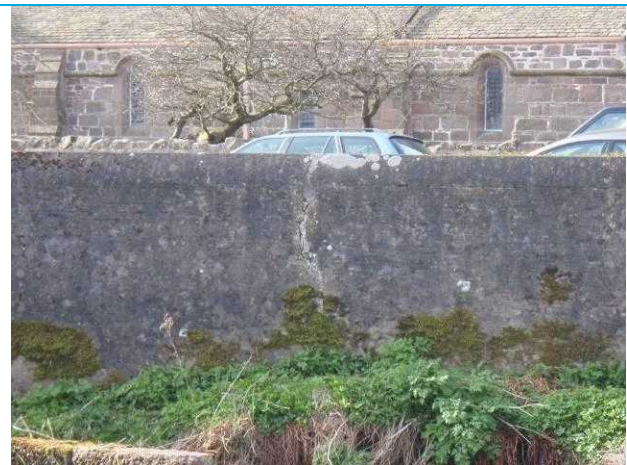
Photograph 4: Crack in wall, likely to be due to thermal and/or moisture movement.

Description	Concrete boundary wall, incorporating gable wall of property.	
Anticipated Ground Conditions	Sand & Gravels.	
Potential Ground Investigation	Type	In situ SPT's, Soil grading
	Access	Access through garden, although hedge may be damaged.
Structural comments	Wall shows little sign of structural movement. Some stones have been placed at foot of wall, and are vegetated. Bank looks reasonably stable.	
Design considerations		
General condition	Good.	
Remedial action required	Crack should be sealed using flexible joint filler.

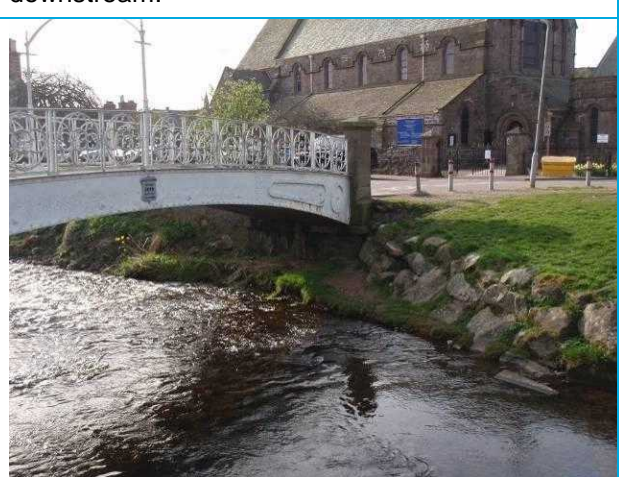
Photograph 8: View of RHB abutment looking downstream.

General condition	Although there is some evidence of rusting bridge appears in good condition.	
Remedial action required	None, although repainting will be required in 5-10 years time.

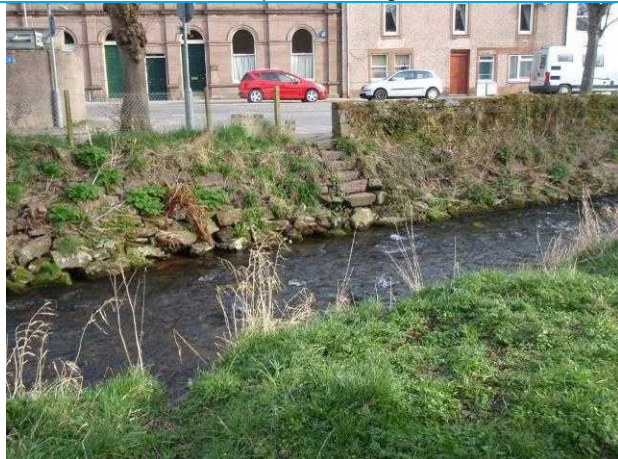
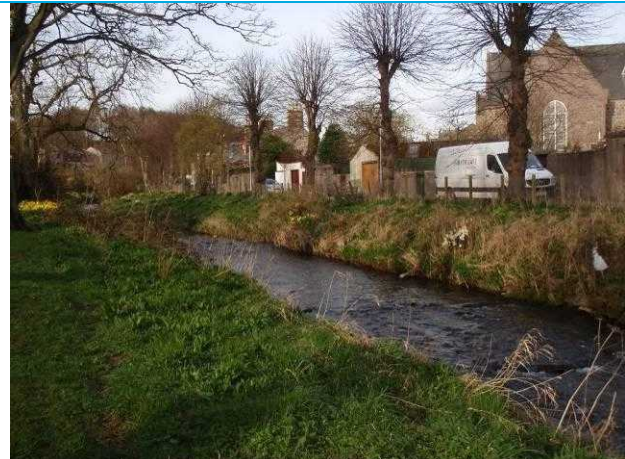
Photograph 1: Downstream end of embankment, note loose stones and presence of voids at base. Note, wall ends at steps reducing level of defence.

Photograph 2: View of embankment looking downstream.

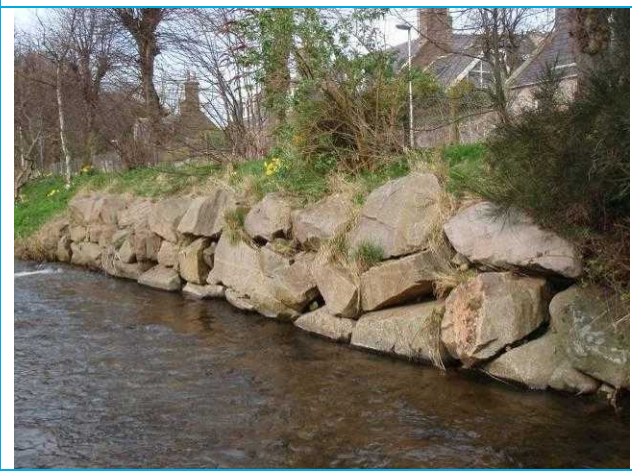
Photograph 6: Area of bank recently consolidated using large boulders.

Description	Vegetated stone and earth embankment.	
Anticipated Ground Conditions	Sand & Gravels.	
Potential Ground Investigation	Type	In situ SPT's, Soil grading
	Access	Good at top of embankment, although services likely to be present and partial road closure req.
Structural comments	Some loose areas and evidence of erosion.	
Design considerations	Any flood defence wall should be built on top of embankment. This may involve narrowing road locally.	
General condition	Fair	
Remedial action required	Consolidation of loose areas, and additional toe protection added as required.

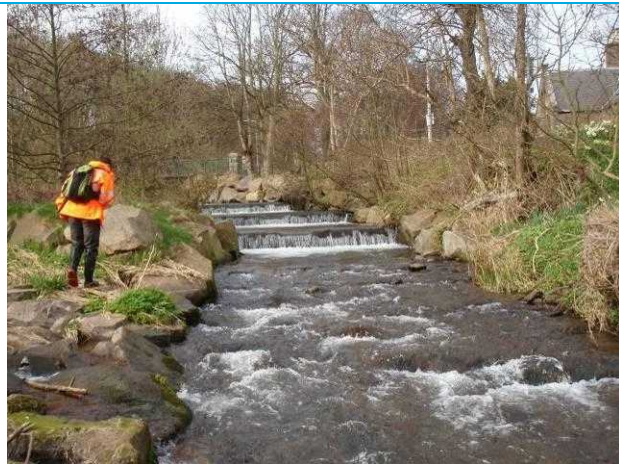
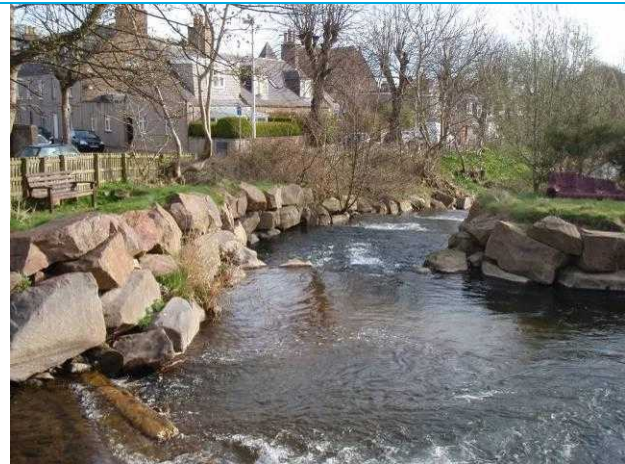
Photograph 1: View looking upstream at weir structure.

Photograph 2: Boulder walls to sides of weir.

Description	Stone embankment.	
Anticipated Ground Conditions	Sand & Gravels.	
Potential Ground Investigation	Type	In situ SPT's, Soil grading
	Access	Good at top of embankment, although services likely to be present and partial road closure req.
Structural comments	No sign of significant movement in structures. Stones of large size do not appear to be affected by erosion of soil.	
Design considerations	Any flood defence wall should be built on top of embankment.	
General condition	Good	
Remedial action required	None

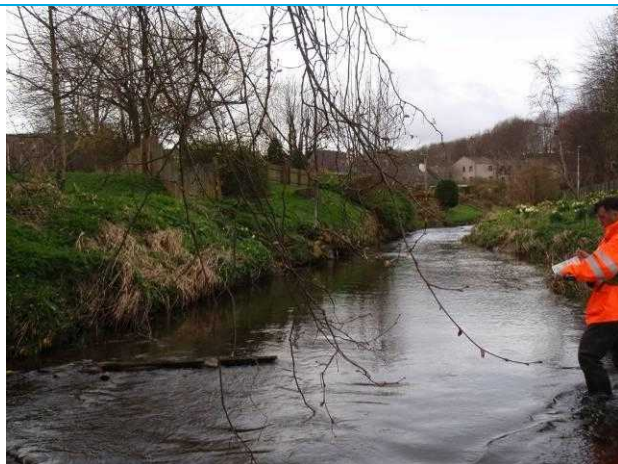
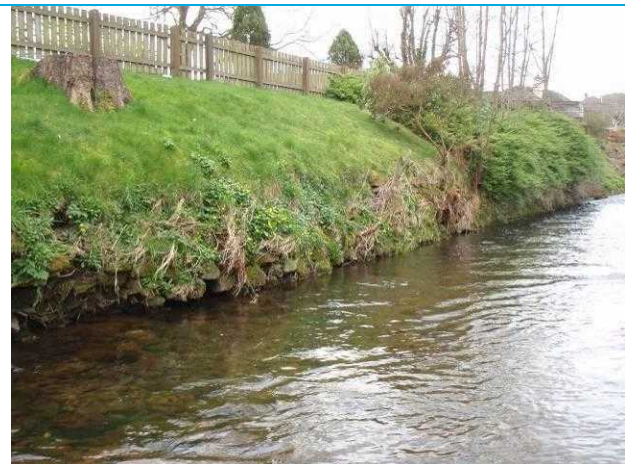
Photograph 3: View looking upstream.

Photograph 4: Dry stone wall at toe of embankment.

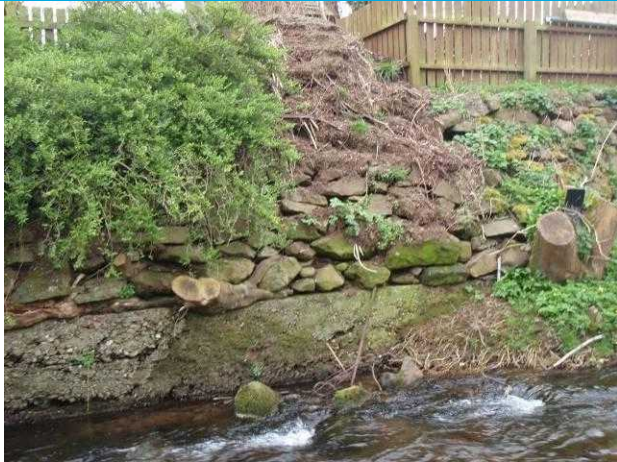
Photograph 5: Drystone wall built on mass concrete wall, note loose stones and tree growth.

Description	Stone and earth embankment with sections of mass concrete and drystone wall. Stone outfall structure.	
Anticipated Ground Conditions	Sand & Gravels.	
Potential Ground Investigation	Type	In situ SPT's, Soil grading
	Access	Generally good, although some areas will be restricted.
Structural comments	Erosion of banks and structures on inside of bend. Some evidence of erosion around outfall structure. Stone embankment either side fish pass in good condition.	
Design considerations	Flood defence walls may be constructed at top of embankment.	
General condition	Fair	
Remedial action required	Consolidation of areas of loose stone required, together with toe protection as necessary.

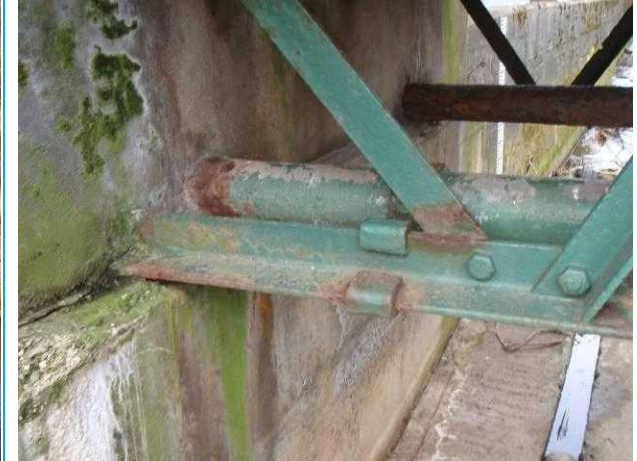
Photograph 2: RHB abutment, note built in beam acting as moisture trap.

Description	Steel truss bridge supporting concrete deck	
Anticipated Ground Conditions	Fill over Sand & Gravels.	
Potential Ground Investigation	Type	In situ SPT's, Soil grading
	Access	Access good, although services likely to be present & partial road closure may be required.
Structural comments	Steelwork showing some signs of corrosion.	
Design considerations	The bridge may be acting as a choke point. To raise this bridge the ends would need to be freed and the bridge jacked up. The abutments may be raised with concrete. This should be relatively easy to do.	
General condition	Good	
Remedial action required	Repainting required in next 5 years.

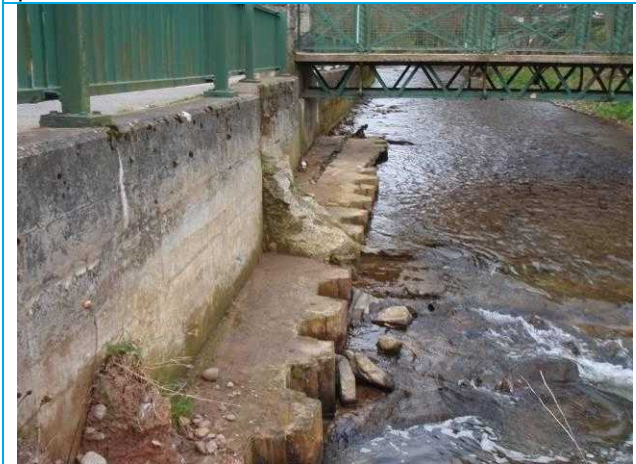
Photograph 5: Photo showing sheet pile toe protection.

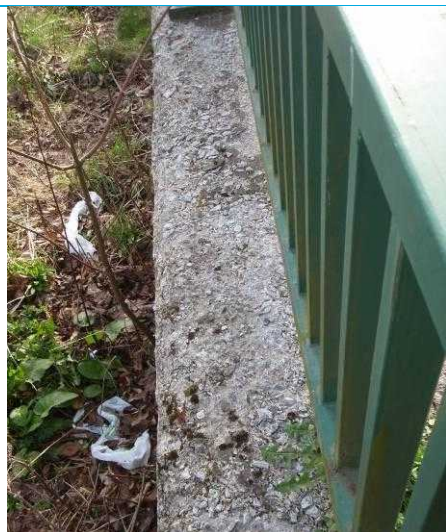
Photograph 3: Spalling to top of concrete wall.

Description	Concrete retaining wall	
Anticipated Ground Conditions	Fill above sands & gravels.	
Potential Ground Investigation	Type	In situ SPT's, Soil grading
	Access	Access good, although services likely to be present & partial road closure may be required.
Structural comments	No signs of movement. Protected adequately from erosion at base. Some spalling to top of wall.	
Design considerations	The height of the wall may be raised by casting a new section of wall on top of the existing.	
General condition	Good.	
Remedial action required	None required.
