Huntly Flood Alleviation Scheme, Huntly, Aberdeenshire

Geomorphology and Water Framework Directive Assessment

Planning Application for Huntly Flood Alleviation Scheme, Huntly, Aberdeenshire

On behalf of
Aberdeenshire Council

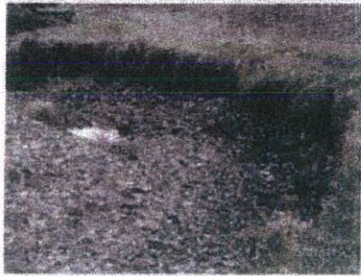
| Channel banks | |
|---|--|
| Erosion of outer meander bend at Milton Farm | Cantilever failure and basal scour |

- 2.7 Channel banks comprise silts and sands with cobble horizons. Riparian vegetation comprises ruderals with occasional trees. Cantilever failure, slumping and basal scour of channel banks is widespread and outer meander bends are particularly unstable and subject to erosion.
- 2.8 Block stone and gabion baskets are present locally as bank protection e.g. along the right bank at Milton Farm. There is some deterioration of the protection and overtopping and collapse of specific sections has occurred.
- 2.9 The potential for ongoing channel bank failure and bank retreat is particularly high where flows are concentrated against bank edges. Key locations include outer meander bends such as the right bank at Milton Farm.

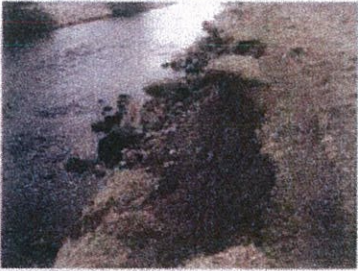
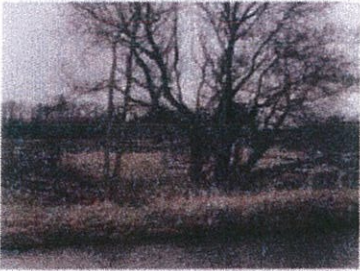
| Channel banks | |
|---|--|
| Channel bank failure | Undercutting on inner meander bend |

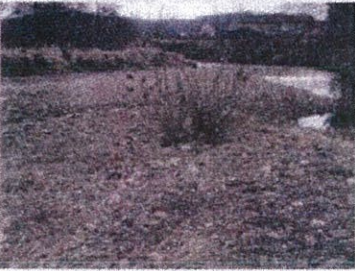
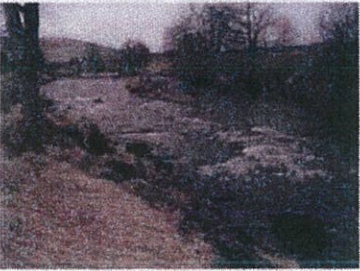
| Channel banks | |
|---|--|
| Coarse bar deposit with limited vegetation | Knickpoint erosion of coarse bedload |

erosion and stabilisation of deposition by vegetation is limited: some growth was noted on the bar deposit near Milton Farm.

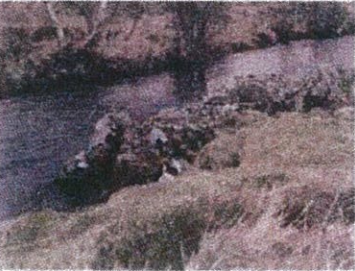
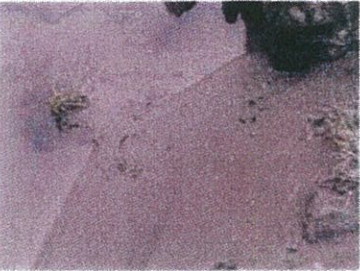
| Channel banks | |
|---|--|
| Granite outcrops | Sandy deposition where stream power is low |

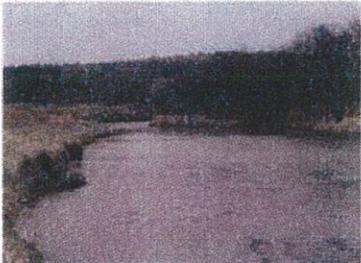
| Reach 1: upstream meander bed, vegetated left bank | Upstream view of Reach 1 |

| Reach 1: upstream meander bed, vegetated left bank | Upstream view of Reach 1 |
|---|--|
| <p>Channel narrower than downstream</p> <p>Left bank protected by trees</p> <p>Some instability and slumping on right bank where riparian vegetation is cleared</p> <p>Floodplain along both banks – rough grassland; A920 adjacent to right bank</p> | |

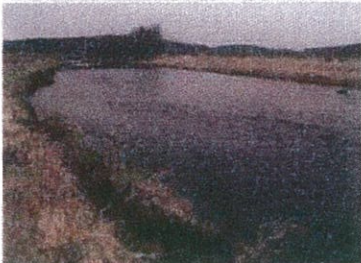
| Reach 1: upstream meander bed, vegetated left bank | Upstream view of Reach 1 |
|---|--|
| Reach 2: upstream meander bend, cleared banks | Upstream view of Reach 2 |

| Reach 1: upstream meander bed, vegetated left bank | Upstream view of Reach 1 |
|---|--|
| <p>Channel width and gradient increase relative to reach 1</p> <p>Trees absent along both banks – ruderal vegetation only</p> <p>Active erosion along right bank; evidence of bank collapse and meander bend development</p> <p>Flow directed towards the right bank</p> <p>Potential for ongoing erosion to encroach on fishermans' access track</p> | |

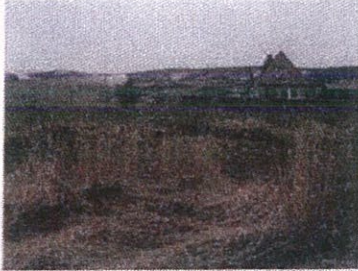
| <p>Reach 3: upstream end of embankment – set back section</p> | <p>View of set-back embankment at Reach 3</p> |

| <p>Set back embankment along right bank adjacent to A920 Active erosion along right bank evidence of bank collapse and meander bend development Flow directed towards the right bank Potential for ongoing erosion to encroach on fisherman's access track and embankment</p> | |

3.10 It is clear that flood protection for Huntly the A96 and the A920 is required and that the proposed renovated embankment upstream from the Burn of Ittingstone in Reaches 3 and 4 is an important component of the flood risk management package. However, the right bank in these reaches is unstable; future erosion is likely and could be rapid.

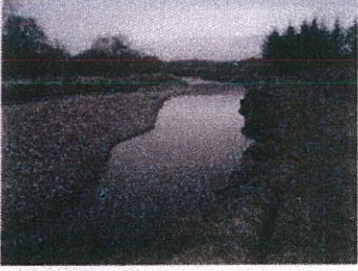
| <p>Reach 4: mid-channel bar upstream Burn of Ittingstone</p> | <p>Downstream view of Reach 4: coarse sediment bar, channel bank scour</p> |

| <p>Embankment alongside right bank Extensive coarse bar deposit ca. 100m long by 15m wide; limited stabilisation by vegetation; sandy deposition where stream power is low Channel narrowed on left-bank side of bar with flow deflected towards the left bank Increased gradient and velocity of flow; flow turbulent Knickpoint erosion of coarse bedload Right bank exposed, scoured and unstable; potential for further scour during high flow events Potential for erosion of fisherman's access track and embankment subsequently; tree and boulders anchor bank locally</p> | |

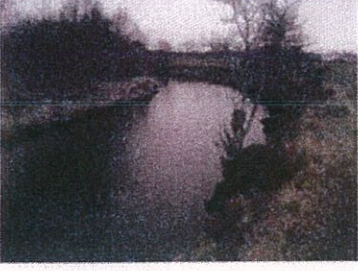
| <p>Reach 5: embanked meander bend through Milton Farm downstream Burn of Ittingstone</p> | <p>Downstream view of Reach 5: failing embankment along right bank outer meander bend</p> |

| <p>Turbulent flow at upstream end of reach Scour and bank failure along left bank Embankment along right bank comprising block stone bank protection overlain by gabion baskets; collapsing locally and likely to degenerate further and reduce flood protection to A96 and Milton Farm. Flow and scour concentrated at toe of right bank; increased channel depth Potential for continued collapse of embankment and for flood risk to adjacent field and loss of fisherman's access path</p> | |

- The existing protection would deteriorate over time, however, the bank is currently stable relative to the adjacent reaches that have no protection and there is the potential for natural regeneration of vegetation to keep step with further deterioration. The existing protection would therefore offer longevity to the set-back embankment; and

- Natural meander development would be reinstated in reach 5 as the existing protection deteriorates over time. It should be noted that this would lead to an increase in the rate of erosion of the right bank compared to that of the existing protected bank. Natural regeneration of vegetation and bioengineering could be employed as mitigation.

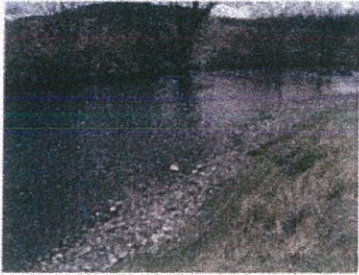
| Reach 6: downstream embanked reach | Downstream view of Reach 6: coarse sediment side bar on inner meander bend |

| Reach 6: downstream embanked reach | Downstream view of Reach 6: coarse sediment side bar on inner meander bend |
|--|--|
| <p>Channel narrower</p> <p>Gravel/cobble side bar on right bank; meander development of left bank</p> <p>Local channel bank erosion via slumping and collapse</p> <p>Channel appears to be regaining stability and equilibrium through local adjustment following the 2009 flood</p> | |
