Area : Banff and Buchan

Parish : Fordyce

Kirkyard : St. Talorgan's old Kirk.

S.A.M. : Scheduled Ancient Monument.

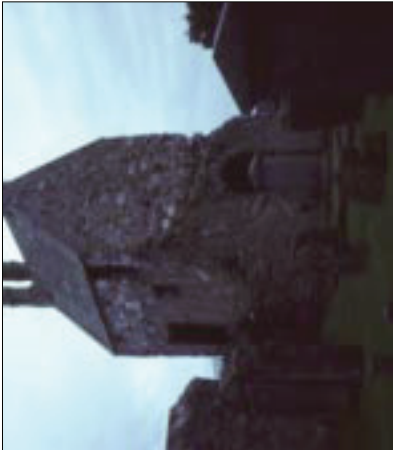
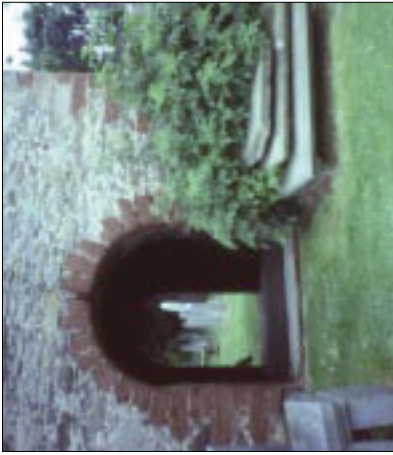
Boundary wall and gate piers : The gates are in good order though they need to be painted, the piers must have the surface weeds removed and joints repointed. The boundary wall, internally and externally, must be cleared of surface weeds and re-pointed throughout. The N.E. corner of the boundary wall must have the rubbish and an inappropriately placed gravestone relocated before this section of the wall can be rebuilt. A well-carved sandstone block, obviously from the Ogilvy of Findlater tomb, lies in this corner and must be put back before it too is lost.

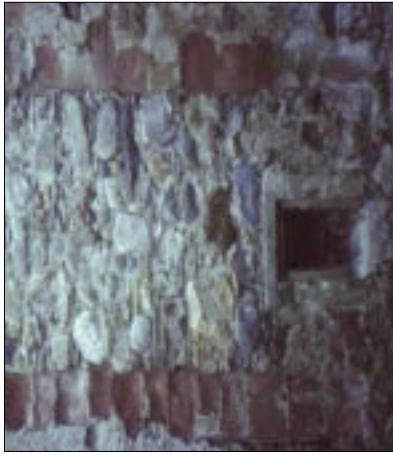
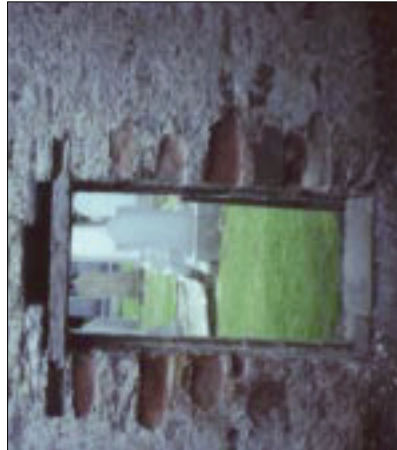
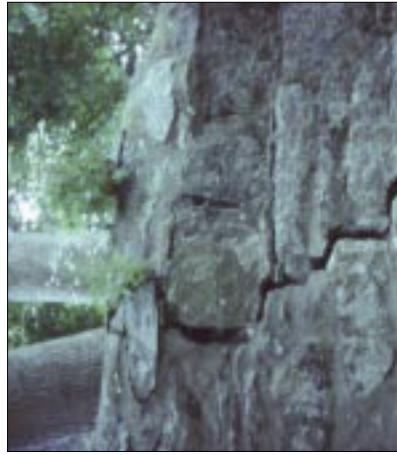
The old Kirk : A complex ruin of fragmentary remains. The original kirk was in the form of a narrow rectangle, of which the chancel now remains and has been sub-divided into two enclosures. The E. enclosure features a “*rich crocketed and cusped ogee arch altar tomb to the Ogilvy of Deskford family*” with a superbly complete recumbent knight effigy.

The W. enclosure features a similar arch although the effigy is long gone and a few select carved stones now lie in its place. – The entire copings to both these enclosures are in bad condition and need re-pointing urgently. Later post-Reformation additions to the kirk include a three-storey gabled tower complete with a “*rich double arched pendant belfry*”

dated 1661. The vaulted ground floor serves as a porch with an external stair leading up to a session room. This room, laid out with a series of information plaques, could be exploited to greater interpretive potential. The entire structure needs to be re-pointed throughout.

The Falconer of Dum aisle, to the E. of the tower, contains a dated monument of 1789. This entire structure is in relatively urgent condition with a rotten timber lintel with the wall-head above cracked. One petrified timber lintel above the entrance must be replaced and the W. and N. walls, not actually engaging, must be stitched together to form a true corner.

The Abercromby of Glassaugh aisle, of square plan with a small plain birdcage bellcote on the N. gable, contains a very fine 1781 memorial executed in polychrome grey and white statuary marble. The memorial is a fine exercise in classicism with a few provincial stylistic quirks. Nonetheless it is in complete contrast to the other monument within the building. The entire enclosure is littered with a build-up of beech leaves and debris which must be removed.
