Aberdeenshire Council
Deveron at Huntly Flood Study
Update
April 2010

Halcrow Group Limited

Aberdeenshire Council appointed Halcrow Group Limited (Halcrow) in December 2009 to undertake a review of the 2005 Deveron at Huntly flood study previously carried out by Halcrow, with specific regard to the flooding which occurred in the town during the 1st and 2nd of November 2009. The main objectives of the study were therefore to assess available hydrological data from the November 2009 event in order to establish its severity; to review the mechanisms of the flood event; and to provide recommendations on potential flood protection measures.

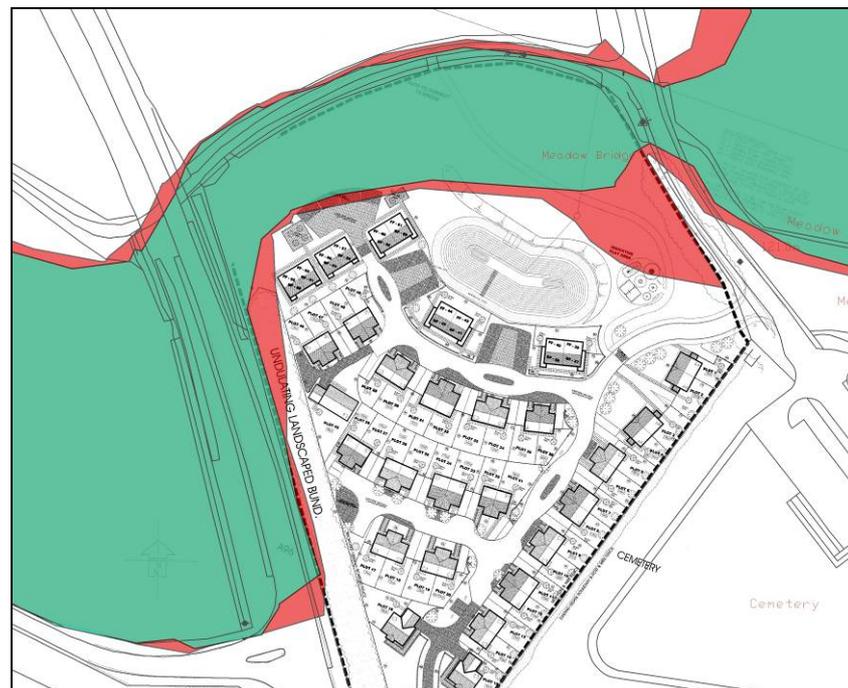
Figure 4-7: Site Layout and original study flood extents

Aberdeenshire Council planning portal was used to retrieve documents relating to the planning application, including the adopted site layout. The site layout can be seen in Figure 4-7 below, overlaid with the 200 and 200+ Climate change event extents developed during the original study.

It shows that the proposed development is generally outwith the 200 year extent and largely also outwith the 200 year plus climate change event. Land has been raised across the development site to afford additional protection from flooding,

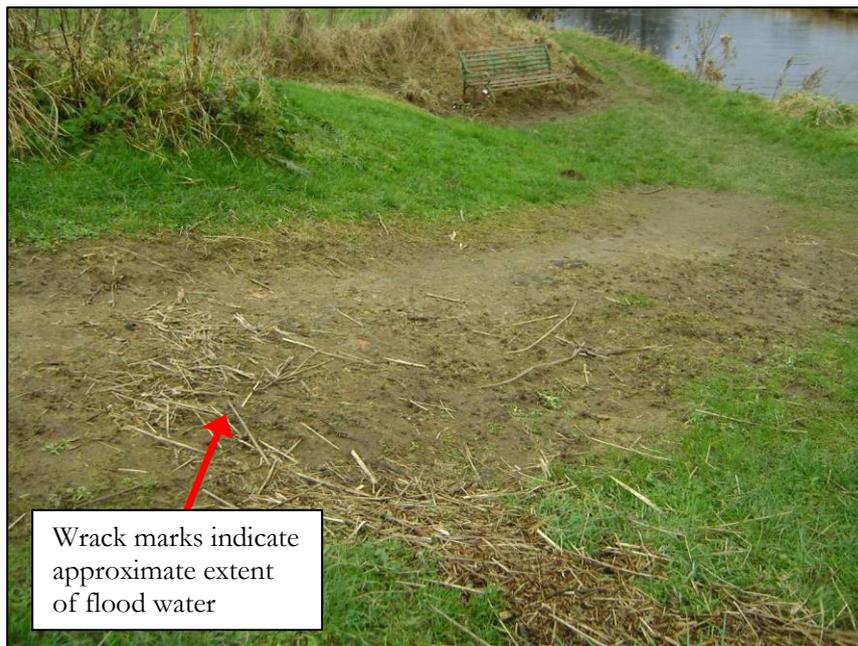
Photograph 11

11	Wrack marks across path indicate flow out of bank in this area
12	Flattened area of grass indicates out of bank flow route on right bank
13	Wooden boundary fence flattened and foundations pulled out by force of water
14	Waterline of properties observable at approximately mid-door height (1m) but local news reports indicate in some properties water depth may have reached 1.5m (5ft)

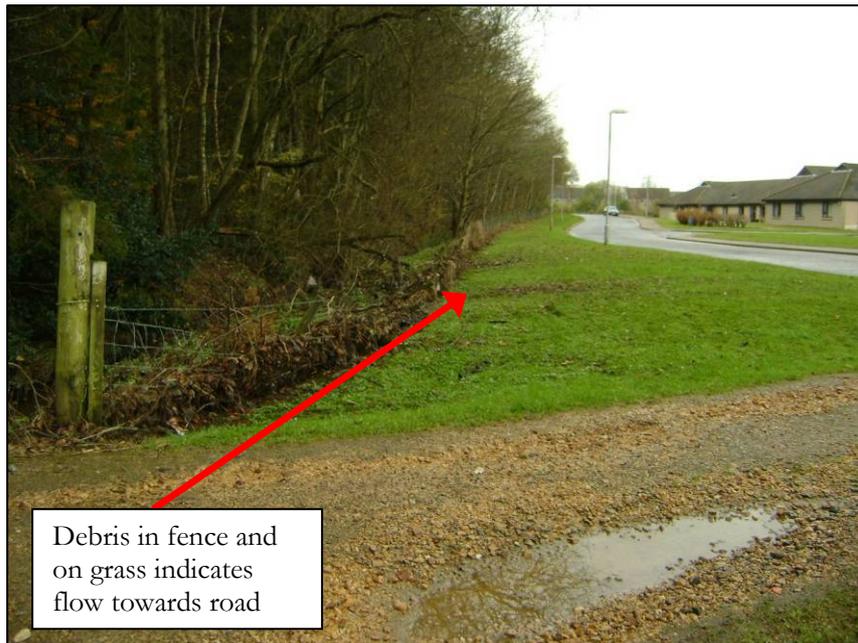
Photograph 15

15	Trash caught in fence indicates flow out of bank towards road
16	Debris trapped to top of fence height and fence flattened indicating significant flow in this area
17	Significant debris trapped in fence on right bank upstream of bridge
18	Tarmac broken up, pipes displaced fences damaged and general debris and silt deposition in surrounding area indicate significant flow and velocity at this location
