# Geomorphological Audit of the River Carron

**Final**

**October 2010**

**Aberdeenshire Council**

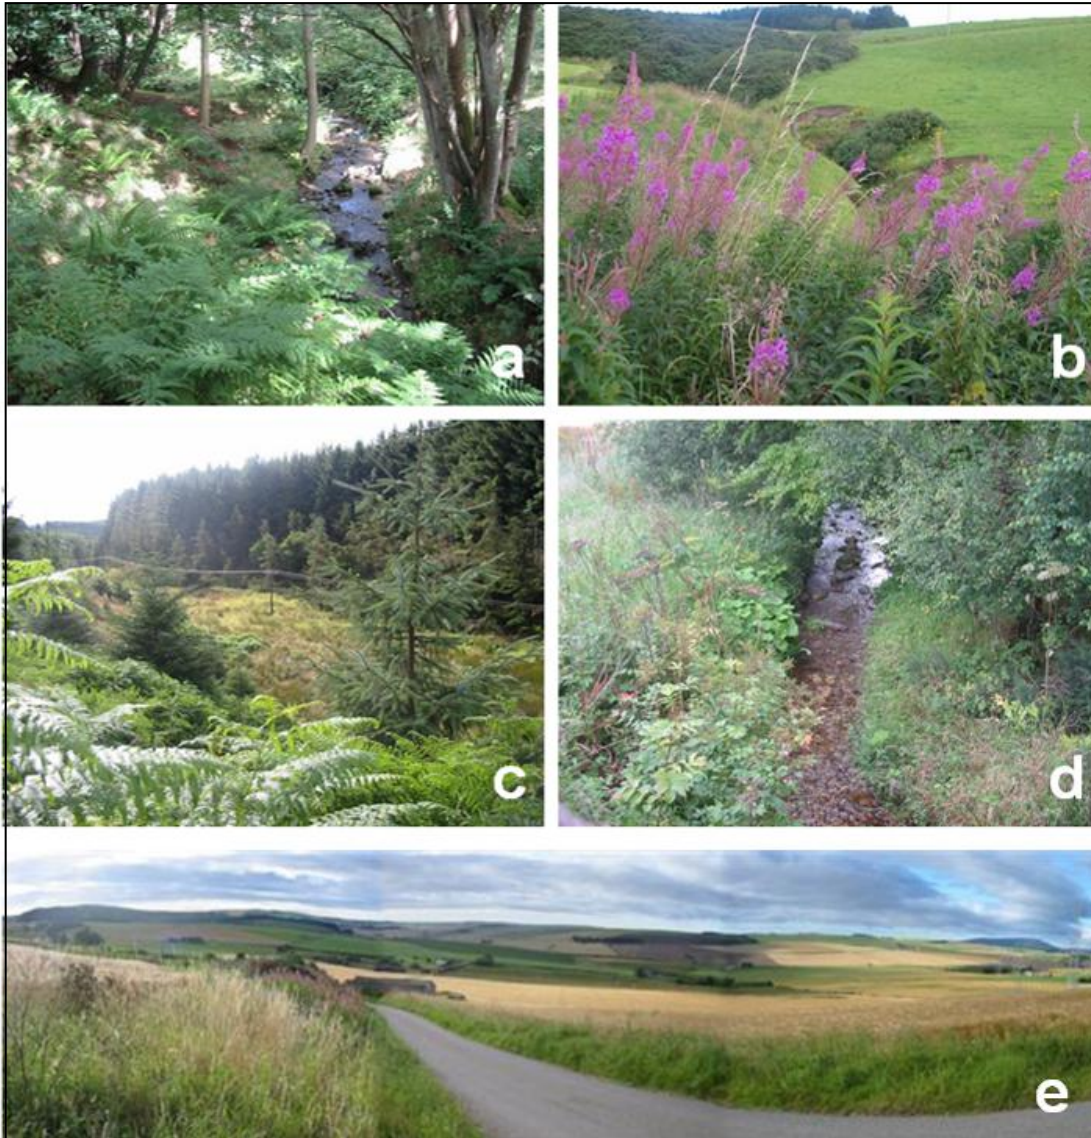
**Figure 3-5: Characteristics of the River Carron in the upper reaches of the catchment.**

The present main channel is generally characterised by a moderate energy single thread gravel-bed channel occasionally splitting through wooded areas of the floodplain (Figure 3-3). The upper reaches are cobble bed step-pool channels with only extremely limited wooded floodplain (Figure 3-5a). Even though the headwaters are confined (Figure 3-5b) sediment supply is low as current geomorphic activity is negligible. Occasional areas of valley infill exist in the upper catchment (Figure 3-5c), these are relic features and erosion of these deposits is negligible. Further downstream the bed material grades into gravels (Figure 3-5d) as the channel flows through its middle reaches. The catchment gradient drops and valley slopes become lower. Much of the area is farmed (Figure 3-5e).

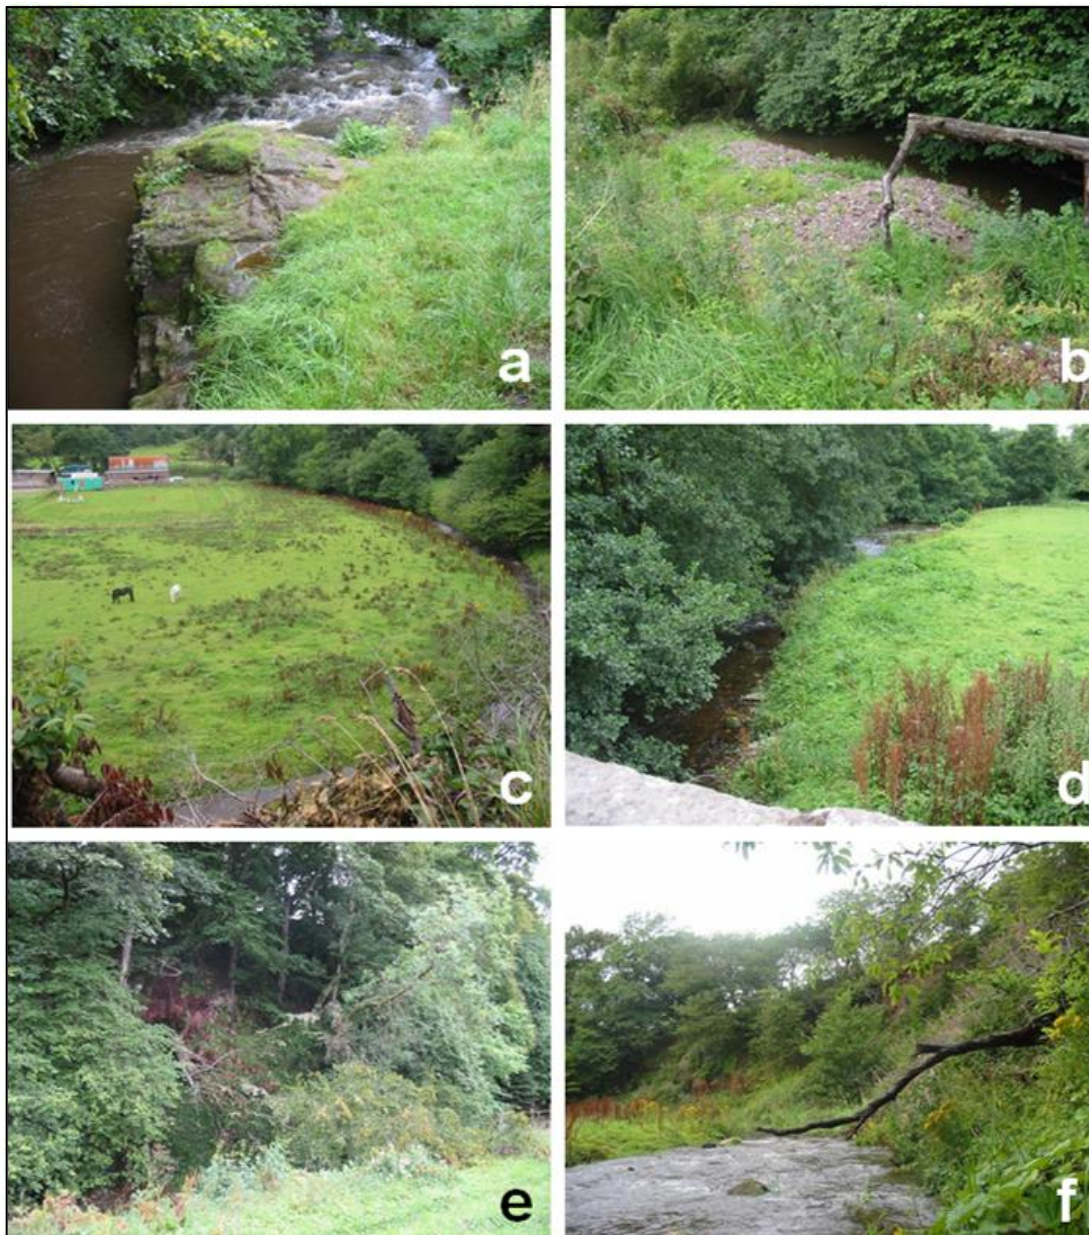
**Figure 3-6: Characteristics of the River Carron in the middle reaches of the catchment.**

Occasional outcrops of bedrock create steeper narrower sections of channel with higher energy flows (Figure 3-6a) and localised gravel bars acting as temporary stores of sediment during low flows (Figure 3-6b). Step pools again dominate. The river has reworked some of the abundant fluvio-glacial deposits in the lower catchment upstream of Stonehaven creating areas of floodplain with high terraces (Figure 3-6c & d). Erosion of the floodplain and terrace material (Figure 3-6e & f) releases slugs of mixed sediment into the main channel for transport downstream. Often the fluvio-glacial deposits are of considerable thickness and even small areas of localised erosion can generate equivalent volumes of sediment to the bar forms that have developed in the channel through Stonehaven.

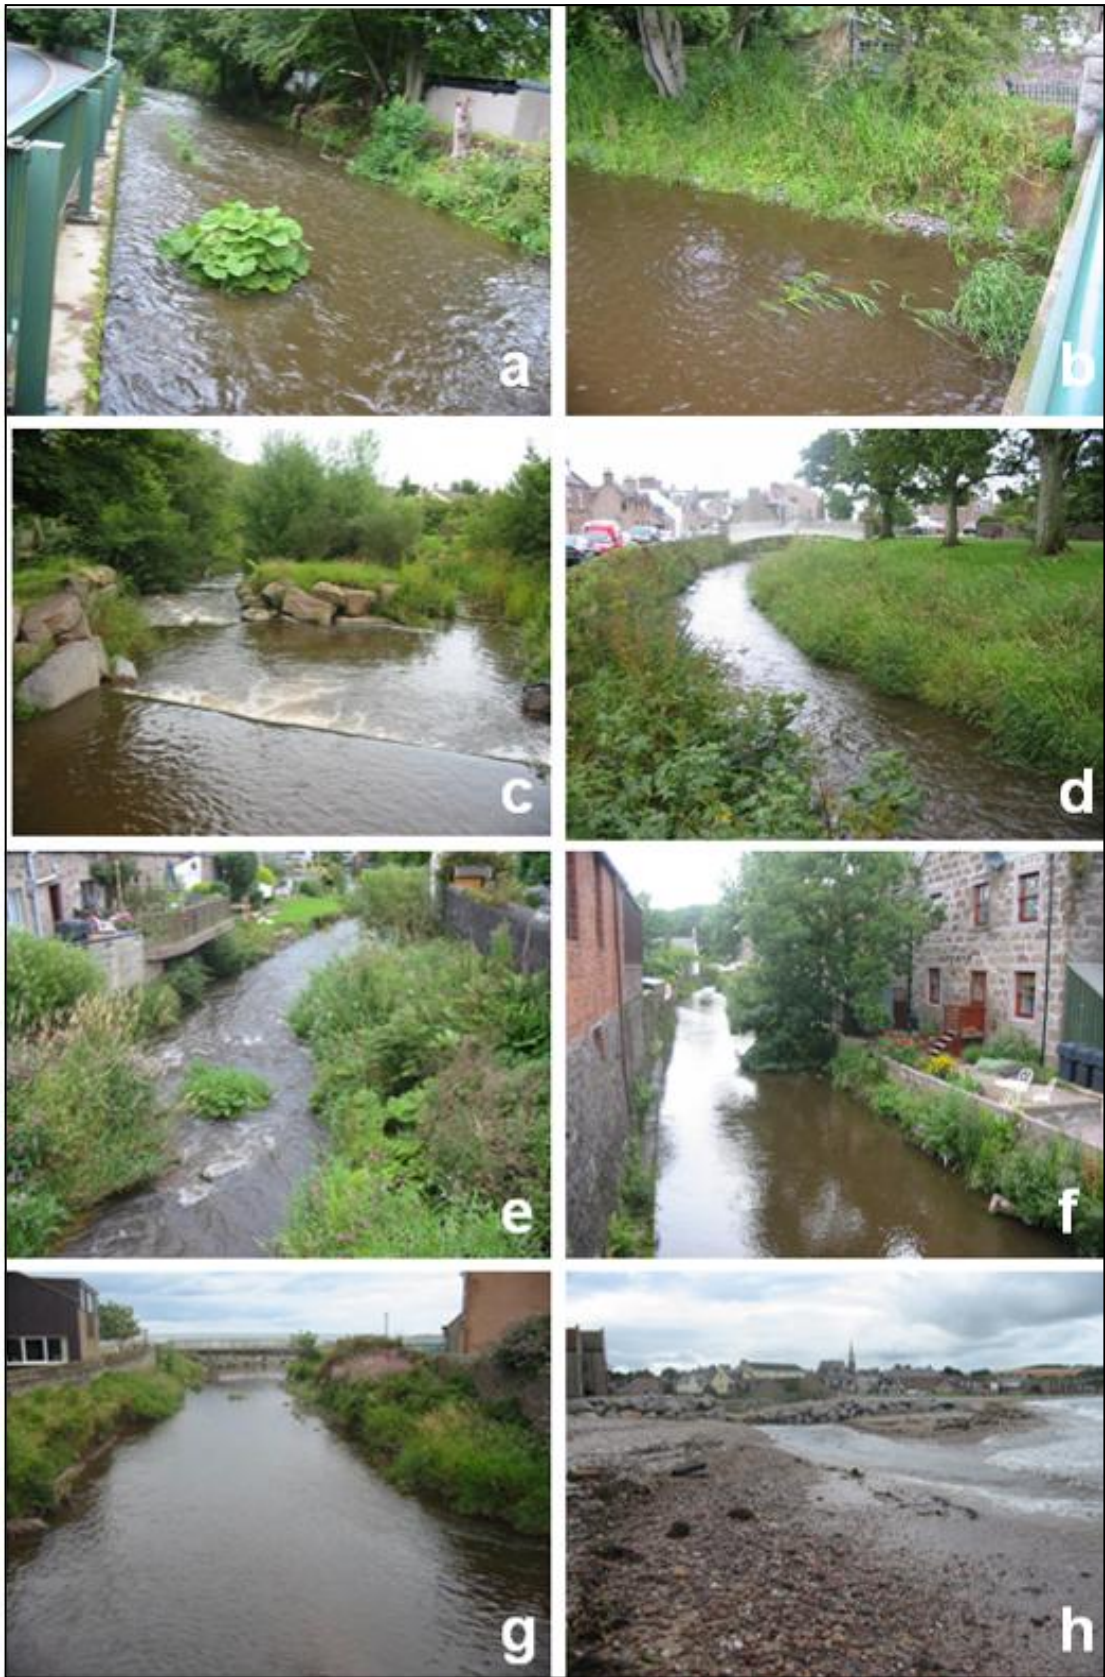
Figure 4-1: Characteristics of the River Carron through Stonehaven.

Practically the entire river downstream of Walker Bridge (Figure 3-1) has been altered to provide flood channel capacity through Stonehaven. Low masonry walls and alder lined banks exist between Walker Bridge and Green Bridge. Here the river is approximately 8m wide increasing to around 10m immediately upstream of Green Bridge. The channel displays a series of pools and coarse gravel riffles grading into a lateral bar feature on the left bank close to Green Bridge (Figure 4-1a). These are natural features characteristic of this type of river and given no change in the planform of the river or flow and sediment regime will continue to form in the same places if removed. The gravels are likely to develop to an equilibrium height. For the riffles this will correspond roughly to the low flow water level, the lateral bar (Figure 4-1b) will be exposed at low flows extending up to a maximum of around 0.5m from the general bed level.

The single span bridge structure itself is having no impact upstream at low and moderate flows and as such is not influencing depositional processes locally. Immediately downstream of the bridge a series of boulder weirs and boulder 'island' have been constructed to control flow energy levels through this extremely steep reach (Figure 4-1c). The engineered structures appear to have been very successful and are becoming naturalised through the deposition of finer material in low energy zones and associated with colonising vegetation.

Channel capacity has been increased in the reach between Green Bridge and White Bridge through the scalping of the right bank meander bend (Figure 4-1d) and the general raising of the banks. Where the channel has been significantly widened under White Bridge there has been considerable deposition of mixed sediments that are now colonised by ruderal vegetation (Figure 4-1e). Deposition here is likely to continue as the channel seeks to attain a smaller equilibrium channel shape. Flood modelling of this reach suggests that there is presently adequate capacity in the vicinity of White Bridge. As such it is recommended that the gravel shoals be retained.

The river between White Bridge and Bridgefield Bridge is constrained by hard engineering. The channel is over-wide at around 12m although this is reduced in a number of locations by the piecemeal construction of lateral structures to gain garden areas for riverside residents (Figure 4-1f). Even though the main channel displays no significant bar deposits the garden features themselves are significantly reducing flood flow capacity through the bottom of the town. Although no historic supporting evidence has been found it is suggested that these gardens would have been constructed on lateral bar deposits present in the over-wide channel. Removal of these features is recommended to improve flood conveyance. Their removal would most likely lead to the reformation of gravel bars, however, they will not build up to occupy the same channel capacity as the present gardens.

Downstream of Bridgefield Bridge tidal influences are encouraging the deposition of silts over bankside riprap. Present fluvial flows are limiting this build up to the extreme channel margins (Figure 4-1g). River flows are also able to maintain a well defined channel between the emplaced boulders at the channel mouth (Figure 4-1h). Periodic build-up of littoral sands and gravels at the mouth are flushed through during high flows and deposited as a fan of coarser material across the beach face.

Given the widespread sources of gravel material upstream and the natural propensity for deposition in the vicinity of Green Bridge the removal of material under and upstream of the Bridge will necessarily be an ongoing maintenance process. It should be noted, however, that engineered in-channel structures in the vicinity of the bridge are encouraging sedimentation. The presence of a log weir immediately downstream of the bridge (Figure 4-1c) coupled with historic local widening of the channel is creating a low energy zone under and upstream of the bridge during low and moderate flows. Deposition is likely in these low energy areas and the sediments are presently being colonised and stabilised by emergent vegetation. Removal of the log weir will improve flood conveyance and general channel capacity through the bridge and will result in a reduced need for dredging along this reach.

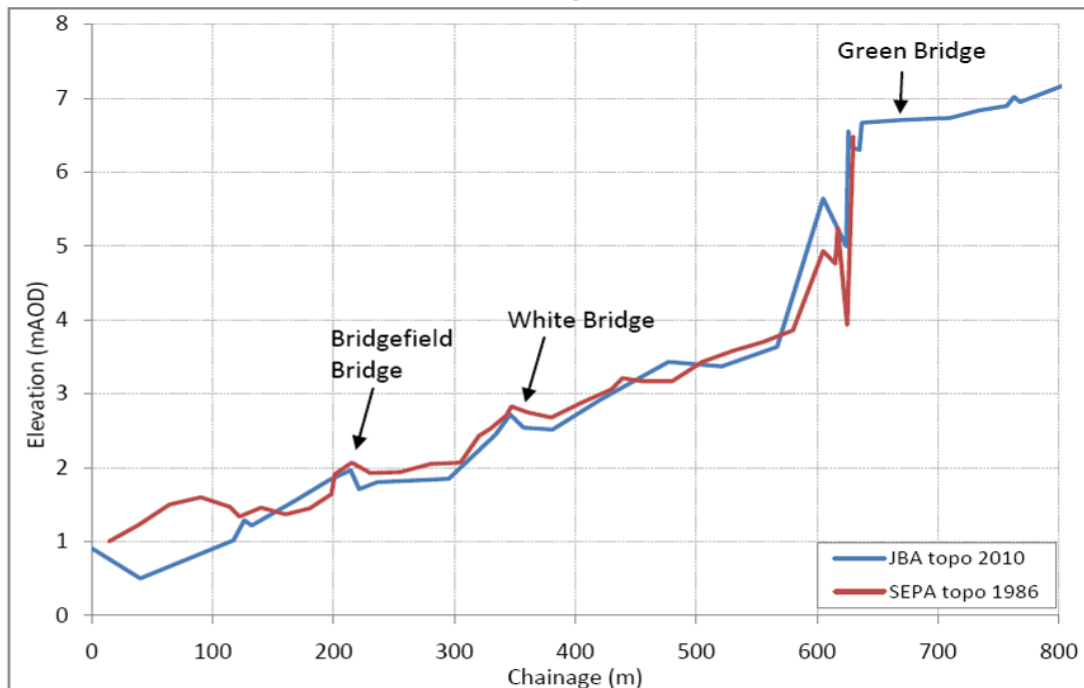
**Figure 4-2: Comparison long sections of the River Carron through Stonehaven (1986 and 2010).**

Comparison of the long section of the River Carron conducted by JBA Consulting<sup>4</sup> and the 1986 channel survey (Figure 4-2) highlight the local depositional zones present in the reach between Green Bridge and Bridgefield Bridge (Unfortunately the 1986 survey did not extend upstream of Green Bridge). General sedimentation along the river appears to be an ongoing issue and this will continue to be the case due to the disruption to the sediment transport regime caused by channel engineering enhancing the ability of the channel to accumulate material at over-widened sites. Given the volume of sediments being released into the river upstream and then transported through to the town sedimentation may be viewed as inevitable under the present regime. Trapping of sediment upstream would reduce the need for removal through the town but may lead to further instability as the river picks up material from the bed of the urban channel leading to bed lowering and / or armouring and associated bank erosion.

Overall it should be noted that the deposition of material on the bed of the channel through the town, although initially quite rapid, would slow down as the river regains a local sediment transport equilibrium. In particular riffle sites will stabilise and are unlikely to impact significantly on flood capacity, occupying only a small volume of the river and increasing channel roughness only marginally at high flows. The bar deposit upstream of Green Bridge is likely to develop to a height of around 0.5m above the general bed level and will become vegetated reducing flood capacity at a critical point in the river. Removal of the log weir under the bridge will serve to increase low and intermediate flow energy levels upstream encouraging riffle development rather than bar deposition, thus increasing flood capacity. This will not impact on the rock weirs downstream. The improved flood conveyance achieved by removing the log weir accompanied by the local morphological switch from bar to riffle deposition should mean that no maintenance dredging will be necessary through this reach.

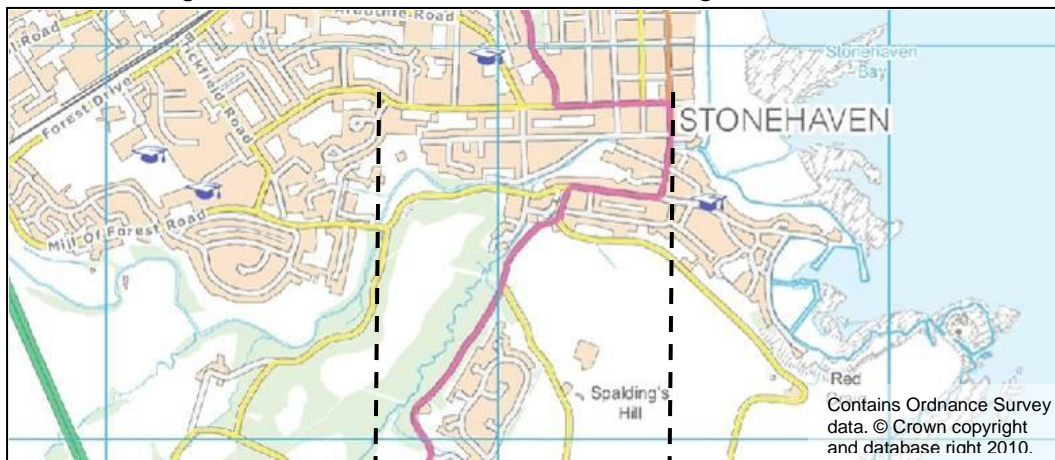
**Figure 4-3: Behaviour of the River Carron through Stonehaven**

Channel widening, particularly around White Bridge is also creating a lower energy zone leading to deposition and a loss of channel capacity. Narrowing the channel here would reduce gravel build-up but it is likely that the re-engineered channel would not display an increased channel capacity as a result due to the narrowing. Similarly the local channel narrowing created by the construction of raised garden areas in the town display a flat channel bed as the present low flow dimensions are closer to the stable shape for the river. Removal of the gardens will lead to bar deposition but these units would not occupy the same channel volume as the present structures. Controls and current river response is summarised in Figure 4-3. Table 4-1 lists recommended actions to improve sediment management on the river and likely related benefits.

Sediment source zone	Weirs Local sediment sinks	Tidal influence
<p>Local erosion of fluvio-glacial sediment sources supplying material for sedimentation through the town.</p> <p>Limited existing floodplain, channel slightly entrenched reducing connectivity and allowing peak flows through to Stonehaven.</p>	<p>Heavily modified channel with disrupted sediment regime.</p> <p>Ample sediment supply to the channel in the town.</p> <p>Repeated build up of gravels where channel is widened and behind weirs.</p> <p>Ad-hoc in-channel structures reducing capacity locally.</p> <p>Very limited options to further enlarge channel capacity.</p> <p>Option to improve sediment transport continuity through modification of weir structure at Green Bridge</p>	<p>Main zone of tidal influence (may extend upriver during high tides). Some local silt build-up.</p> <p>Flood flows able to maintain sediment free channel mouth.</p>

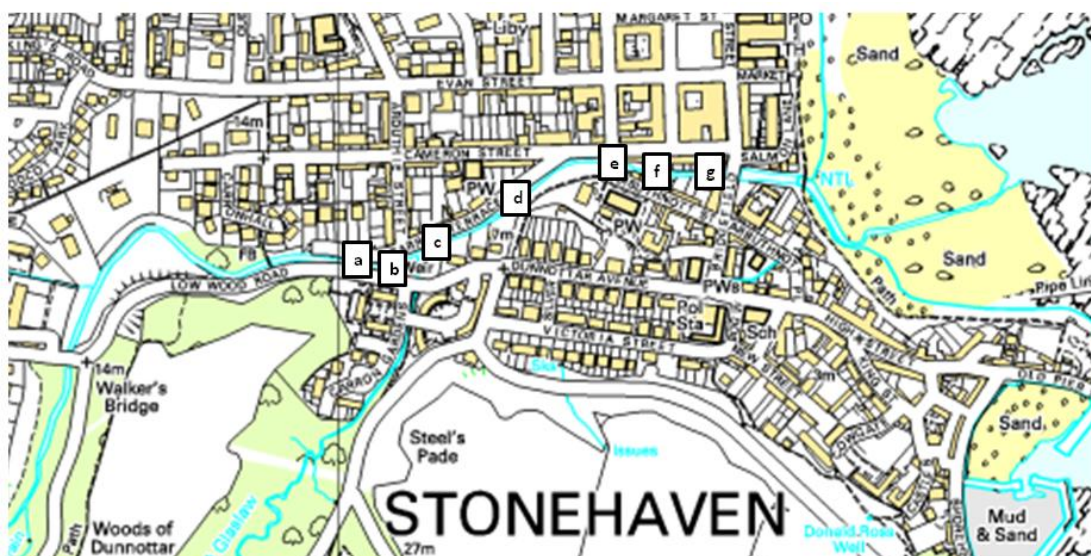
Figure 5-1: Recommended actions for the River Carron through Stonehaven

The following statements regarding sediment management and flood control relate to general conditions operating on the river. Extreme events do occur and result in disequilibrium conditions. These events are not predictable and may result in changes to the river, including excessive sedimentation, which require intervention to restore flood capacity. The proposed actions are summarised in Figure 5-1.

- a** Dredge bar deposits in conjunction with log weir removal.
- b** Remove log weir structure.
- c** Retain boulder weir complex.
- d** Create 2stage high flow channel where space allows.
- e** Retain gravel shoals under bridge. Periodic weed cutting.
- f** Remove in-channel structures on left bank.
- g** Remove in-channel structures on left bank. Monitor bar sedimentation.
