## **C.7 Summary reports**

### C.7.2 Reports

Reference & Chainage <sup>1</sup>	<b>RS1</b> <b>0.000-0.125</b>	Location	OS NGR 387585,785681
Date of Inspection	7 April 2010	Inspector(s)	Stephen Farrar
Nature of Inspection	Visual	Nature of Assets	Rock Revetment
Model cross section showing peak 0.5% AP (200 year) event water level

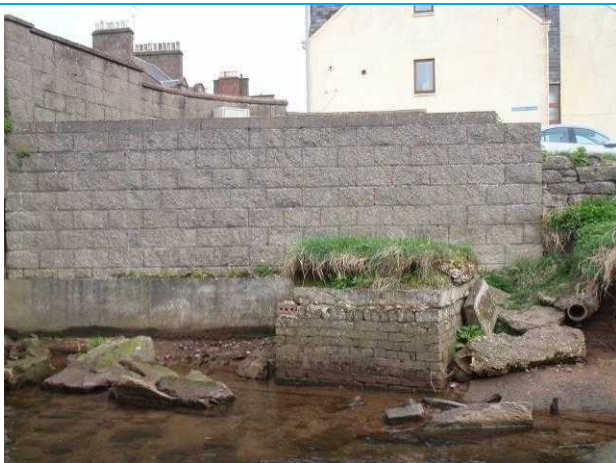
Photograph 2: Some delamination of outerskin of blockwork, coping missing.

Description	Reinforced blockwork wing wall on concrete footing.	
Anticipated Ground Conditions	Sand & Gravels.	
Potential Ground Investigation	Type	In situ SPT's, Soil grading
	Access	Access through walled garden, possibly accessible for terrier rig.
Structural comments	No major signs of structural movement, some deterioration to top of wall. Depth of foundations not known, although it is likely that a scour assessment has been carried out by the council, as sheet piling toe protection has been installed on the other side.	
Design considerations		
General condition	Very Good	
Remedial action required	Minor repairs to top of wall.

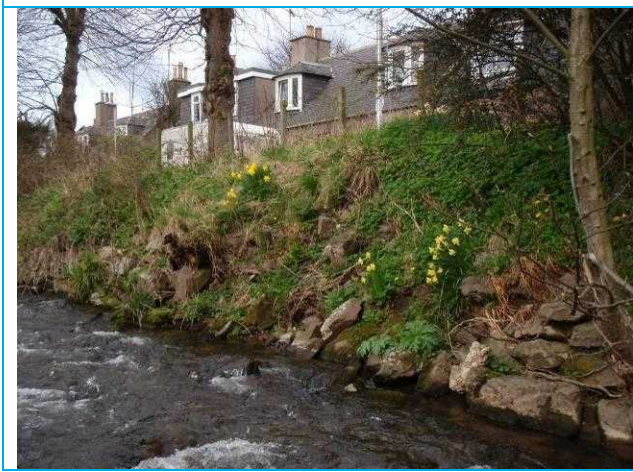
Photograph 6: Area of bank recently consolidated using large boulders.
