## **C.7 Summary reports**

### C.7.2 Reports

Reference & Chainage <sup>1</sup>	<b>RS1</b> <b>0.000-0.125</b>	Location	OS NGR 387585,785681
Date of Inspection	7 April 2010	Inspector(s)	Stephen Farrar
Nature of Inspection	Visual	Nature of Assets	Rock Revetment
Model cross section showing peak 0.5% AP (200 year) event water level

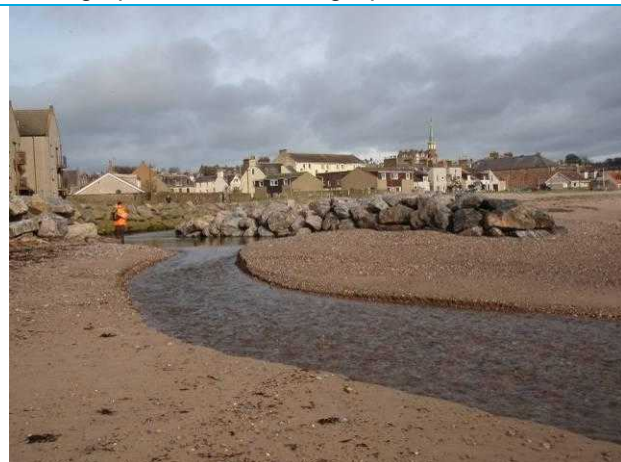
Photograph 1: View Looking Upstream

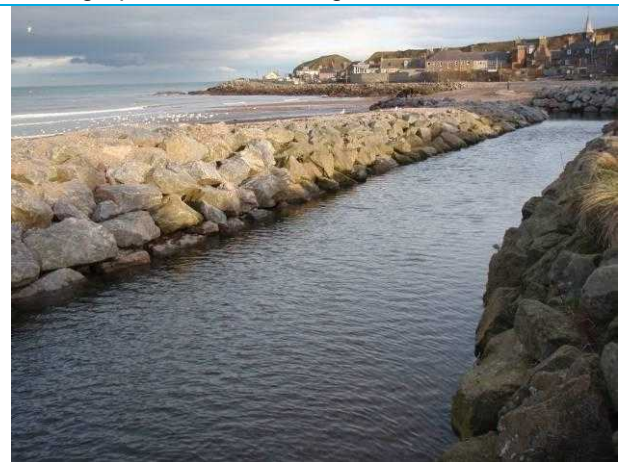
Photograph 2: View Looking Downstream

Description	Rock Revetment provided placed to prevent route of river channel changing, on beach near housing. Embankment approx 2m high.	
Anticipated Ground Conditions	Loose Sand.	
Potential Ground Investigation	Type	SPT's
	Access	Good
Structural comments	The stones were angular and reasonably well packed, varying in size from approx. 0.5-1.5m across. There is no major evidence of settlement or movement in the stone. There is evidence that a geo-membrane has been used to prevent fines washing out from behind the stones. It would also appear that the lower stones are well embedded into the sand at the base of the embankment.	
Design considerations	It is unlikely that any work is required at this point, as this element is not restricting channel capacity.	
General condition	Condition of revetment is good.	
Remedial action required	None

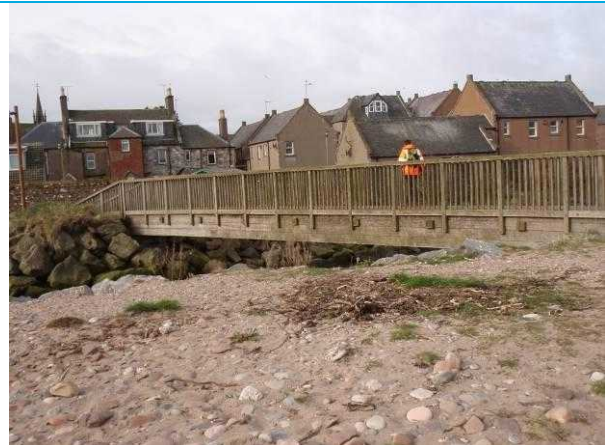
Photograph 2: LHB Abutment

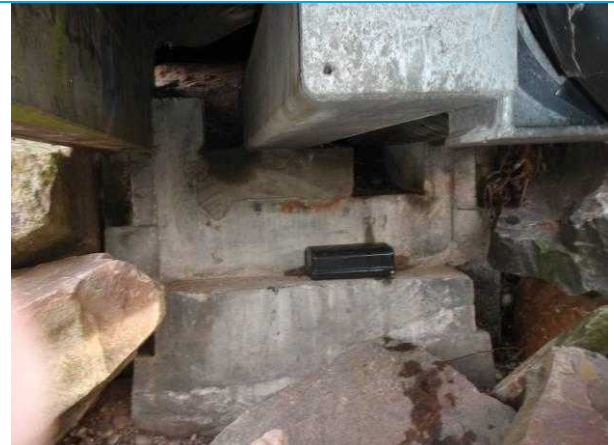
Photograph 3: RHB Abutment, note evidence of previous bridge, below existing beams.

Description	Stressed laminated timber footbridge made of tropical hardwood, fixed together with stainless steel bolts, with mass concrete abutments. It would appear to be a replacement for a previous footbridge, the ends of whose beams remain in the abutments, which have been reused.	
Anticipated Ground Conditions	Loose Sand/Shingle.	
Potential Ground Investigation	Type	SPT's
	Access	Good
Structural comments	There were no major signs of deterioration, although the bearing detail could act as a moisture trap leading to rot. However the timber species used is likely to be durable or very durable.	
Design considerations	Although the beam ends appear partially built in, it should be possible to break out the surrounding concrete to raise the bridge if required.	
General condition	The bridge was in very good condition.	
Remedial action required	None

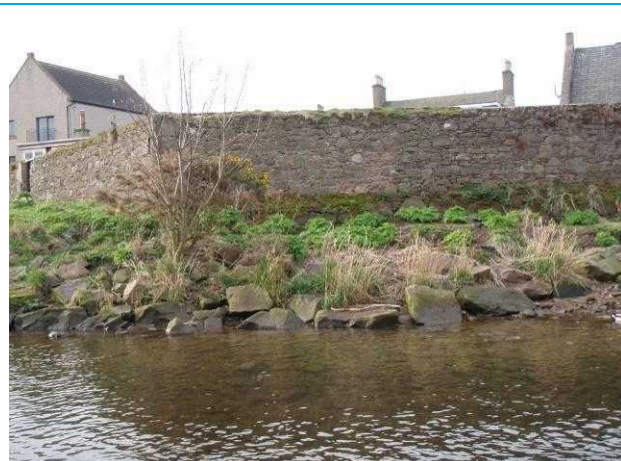
Photograph 1: Eastern end of wall and embankment below.

Description	Random rubble stone wall, founded on embankment with splayed foundation.	
Anticipated Ground Conditions	Sand & Gravels.	
Potential Ground Investigation	Type	Hand Dug Trial Pits behind/in front of wall to establish depth of footings. In situ SPT's, Soil grading tests.
	Access	Good along beach. Through walled garden along river.
Structural comments	Wall showed no sign of major structural movement. The wall looks well constructed and would appear to date from a similar period to the older houses, possibly late 19th Century or early 20th Century. Given its age it is in good condition, although much of the pointing was loose or missing. It was also affected by the growth of vegetation in some areas.	
Design considerations		
General condition	The overall condition of wall and embankment is considered fair, although there is the possibility of this deteriorating quite rapidly to poor if no maintenance carried out.

Remedial action required	The wall will need repointing preferably in a lime based mortar, to match original materials, by suitably qualified craftsmen. Action should be taken to slow erosion at the toe of the embankment.

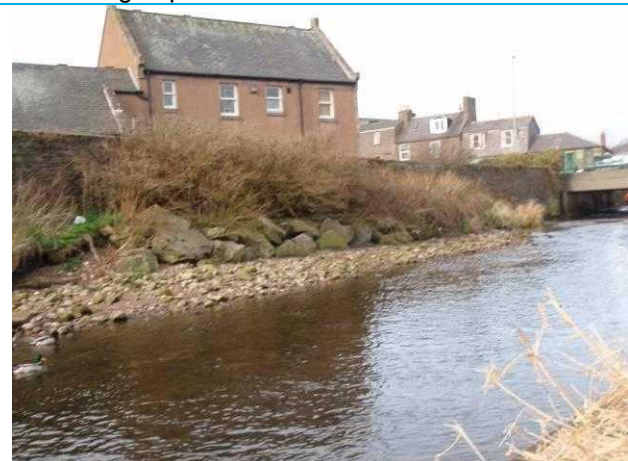
Photograph 2: View of wall looking Upstream, note presence of bank erosion and presence of rock armouring to prevent this.

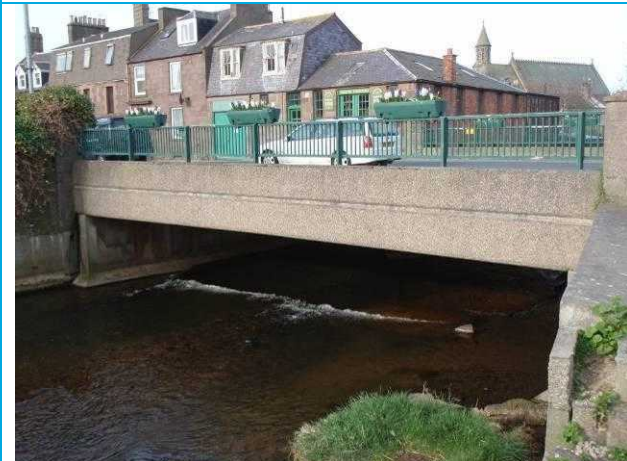
Photograph 2: Blockwork wing wall showing some signs of settlement.

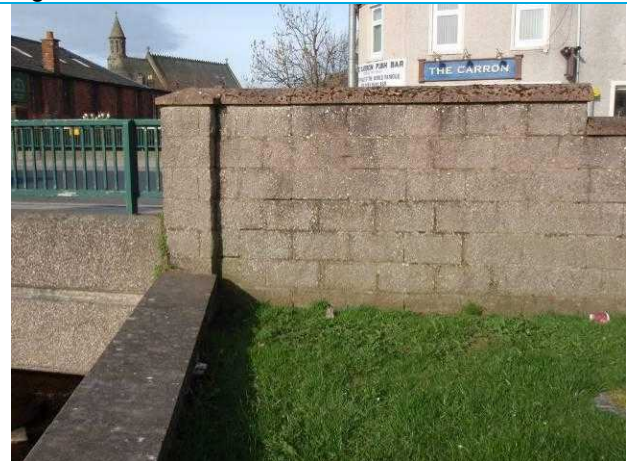
Photograph 3: RHB abutment, note sheet piling to protect toe.

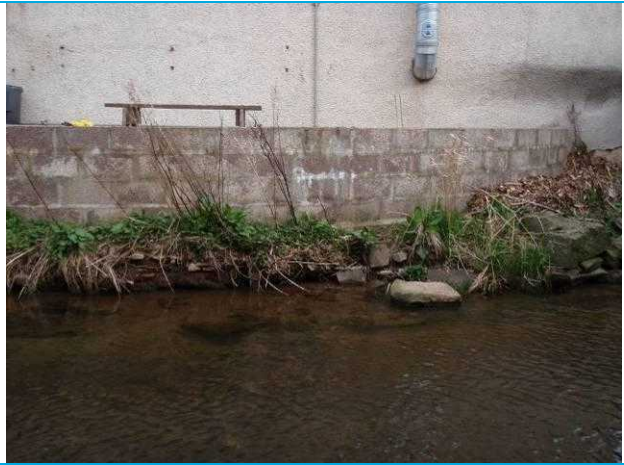
Photograph 3: Upstream end of wall showing collapse of section (believed to have occurred during November 2009 flood event).

Description	Single skin blockwork wall on edge of river channel.	
Anticipated Ground Conditions	Sand & Gravels.	
Potential Ground Investigation	Type	In situ SPT's, Soil grading
	Access	Access limited to hand tools. A rig could be lifted with crane from bridge.
Structural comments	Wall partially collapsed large areas of the river bank below footings eroded.	
Environmental considerations		
Design considerations	The wall is not providing any protection to the property to the rear.	
General condition	Very Poor.	
Remedial action required	Toe protection, combined with new wall required, or new wall with sufficiently deep footings required.

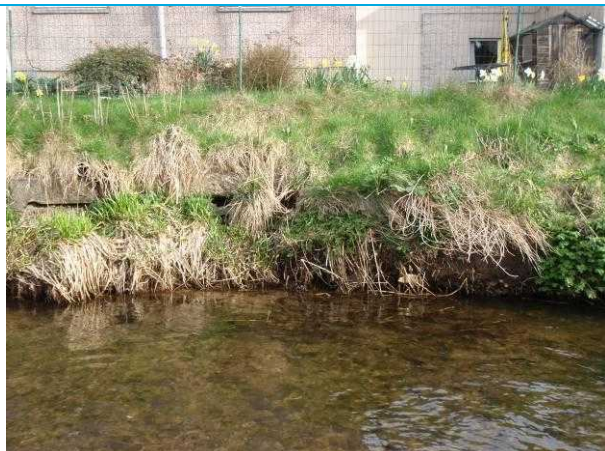
Photograph 4: View of downstream end of wall, wall possibly partially collapsed and bank vegetated.

Description	Stone wall extended with brickwork at upstream end.	
Anticipated Ground Conditions	Sand & Gravels.	
Potential Ground Investigation	Type	In situ SPT's, Soil grading
	Access	Access through walled garden, possibly accessible for terrier rig.
Structural comments	This wall appears to be gradually collapsing into the river. However, due to the size of stones used they are still proving some protection to the toe of the bank.	
Design considerations	The wall would not provide any protection from flooding.	
General condition	Poor	
Remedial action required	Toe protection, combined with new wall required, or new wall with sufficiently deep footings required.

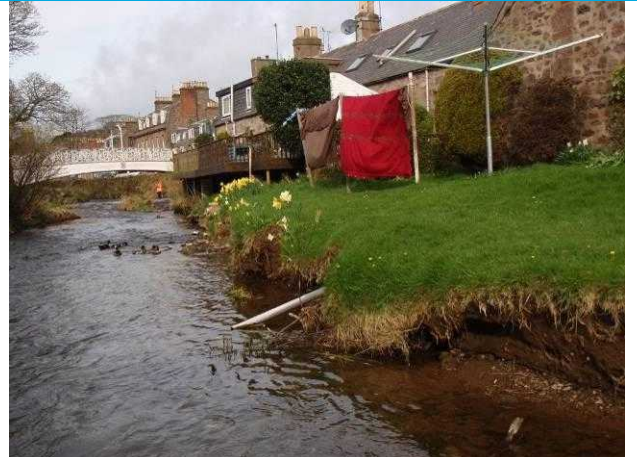
Photograph 1: View upstream towards timber decking, note erosion river bank.

Description	Assorted walls and bank protection.	
Anticipated Ground Conditions	Sand & Gravels.	
Potential Ground Investigation	Type	In situ SPT's, Soil grading.
	Access	Access through walled garden, possibly accessible for terrier rig.
Structural comments	River bank is being eroded, despite 'nominal' edge protection. The timber decking is likely to collapse in a flood. The upstream sections of wall look stable at present, although the depth of foundations is not known.	
Design considerations		
General condition	Poor	
Remedial action required	The upstream sections of wall may require toe protection and repointing. Elsewhere toe protection, combined with new/strengthened wall will be required.

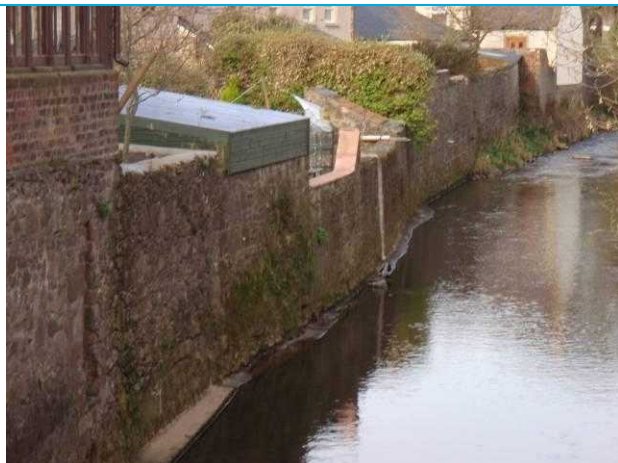
Photograph 2: View looking downstream, showing where wall has been built up in brickwork, and incorporated into property. Note concrete toe protection.

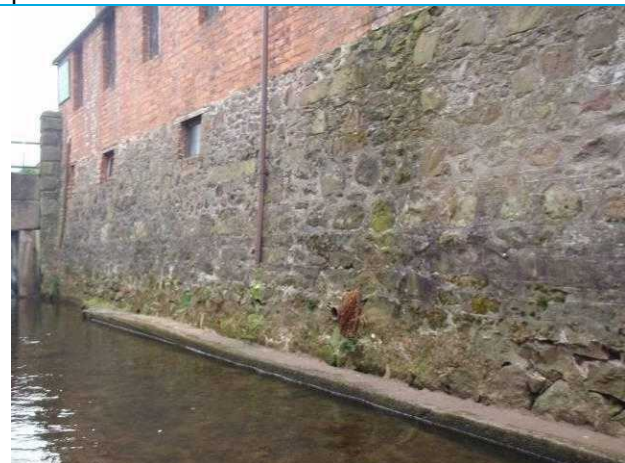
Photograph 3: View of wall showing open joints.

Description	Traditionally built random rubble stone wall, comprising variety of different sections.	
Anticipated Ground Conditions	Sand & Gravels.	
Potential Ground Investigation	Type	In situ SPT's, Soil grading
	Access	Access through walled garden, possibly accessible for terrier rig.
Structural comments	There were no signs of significant structural movement. Toe protection was generally present and intact, although the depth of this is not known. There were areas of loose stone, and open joints.	
Design considerations		
General condition	The general condition of the wall is considered fair.	
Remedial action required	Consolidation and repointing of stonework in materials to match original construction.

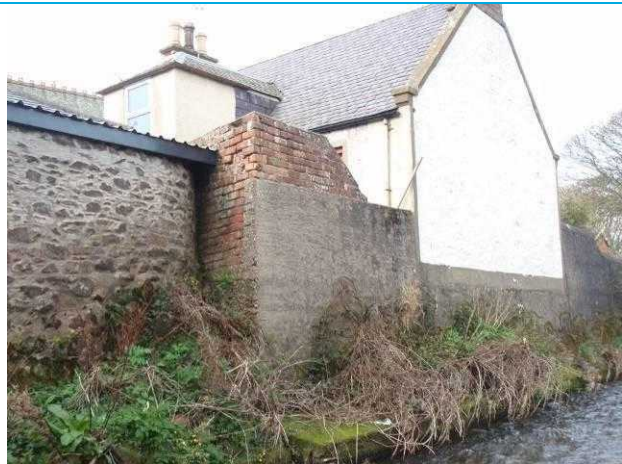
Photograph 2: Middle section of wall.

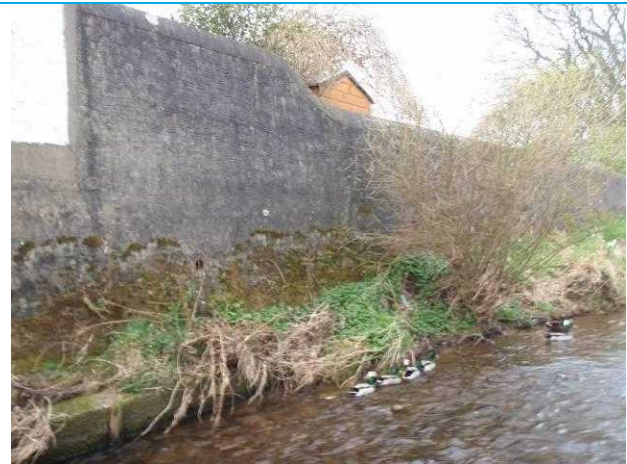
Photograph 3: Upstream end of wall.

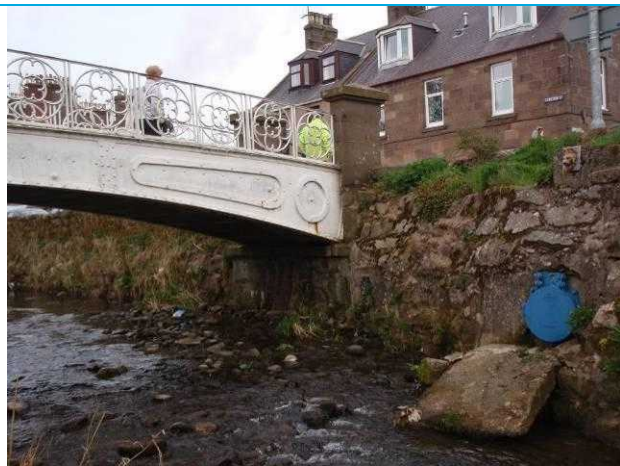
Photograph 4: View underneath bridge.

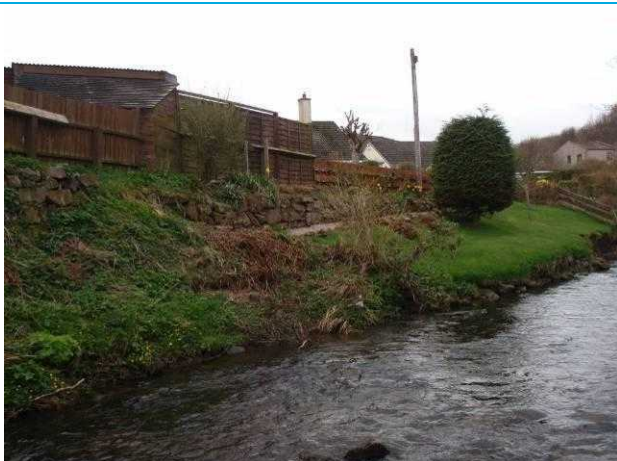
Photograph 8: View showing localised erosion.

Description	Stone and earth embankment with sections of mass concrete and drystone wall. Stone outfall structure.	
Anticipated Ground Conditions	Sand & Gravels.	
Potential Ground Investigation	Type	In situ SPT's, Soil grading
	Access	Generally good, although some areas will be restricted.
Structural comments	Erosion of banks and structures on inside of bend. Some evidence of erosion around outfall structure. Stone embankment either side fish pass in good condition.	
Design considerations	Flood defence walls may be constructed at top of embankment.	
General condition	Fair	
Remedial action required	Consolidation of areas of loose stone required, together with toe protection as necessary.

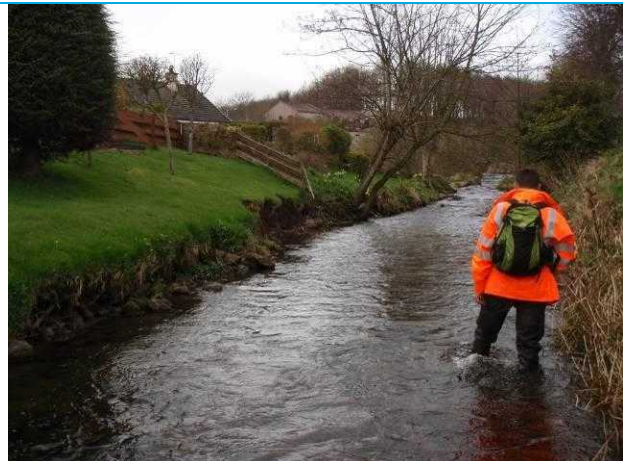
Photograph 9: Close up view showing localised erosion.

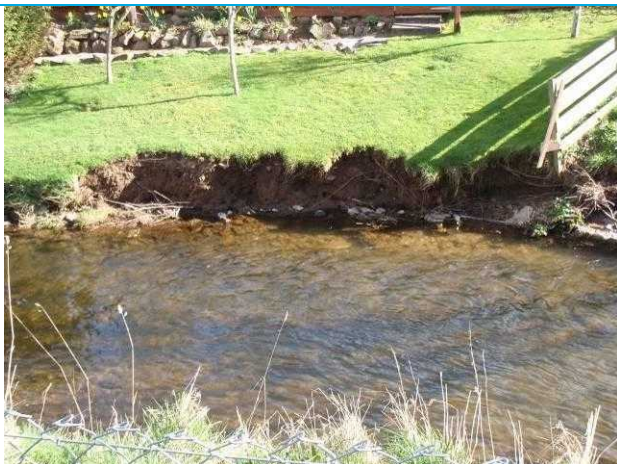
Photograph 10: Local erosion.

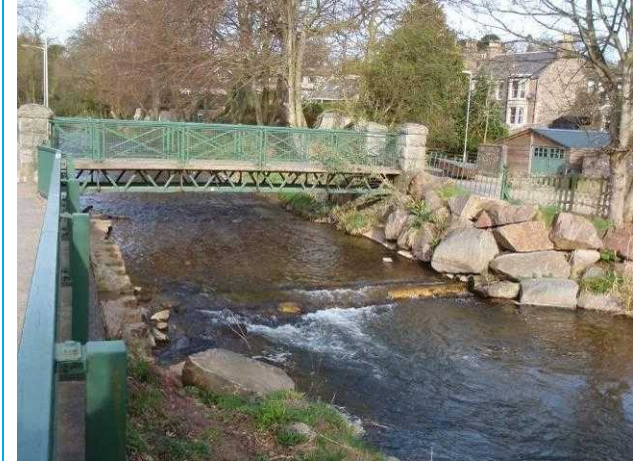
Photograph 2: RHB abutment, note built in beam acting as moisture trap.

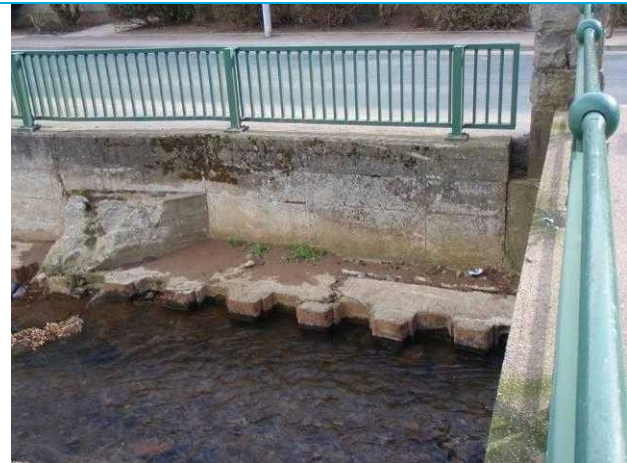
Photograph 3: Spalling to top of concrete wall.

Description	Concrete retaining wall	
Anticipated Ground Conditions	Fill above sands & gravels.	
Potential Ground Investigation	Type	In situ SPT's, Soil grading
	Access	Access good, although services likely to be present & partial road closure may be required.
Structural comments	No signs of movement. Protected adequately from erosion at base. Some spalling to top of wall.	
Design considerations	The height of the wall may be raised by casting a new section of wall on top of the existing.	
General condition	Good.	
Remedial action required	None required.

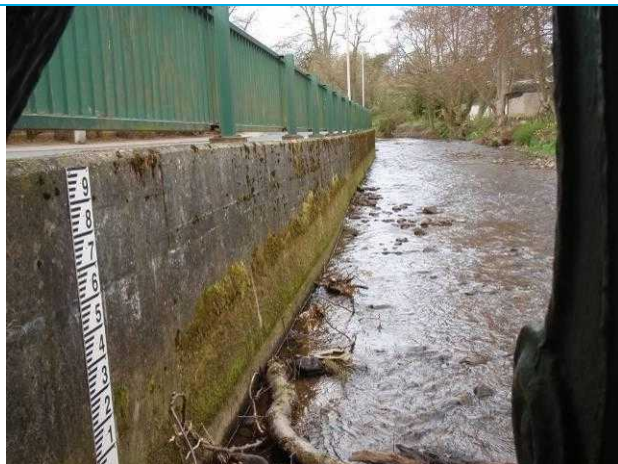
Photograph 1: View looking upstream along wall.

Description	Concrete retaining wall	
Anticipated Ground Conditions	Fill above sands & gravels.	
Potential Ground Investigation	Type	In situ SPT's, Soil grading
	Access	Access good, although services likely to be present & partial road closure may be required.
Structural comments	No signs of movement. Unclear how deep footings go, although there are no signs of wall being undermined.	
Design considerations	The height of the wall may be raised by casting a new section of wall on top of the existing.	
General condition	Good.	
Remedial action required	None required.

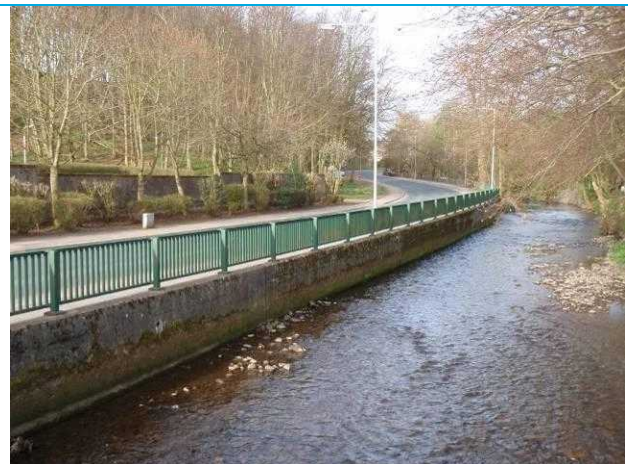
Photograph 2: Elevation wall.

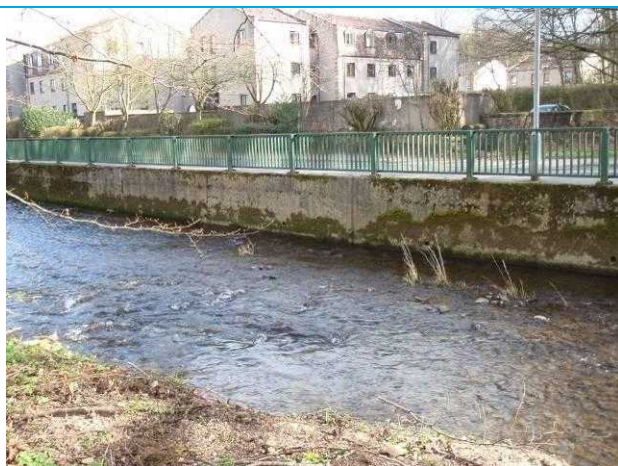
Photograph 3: Middle section wall.

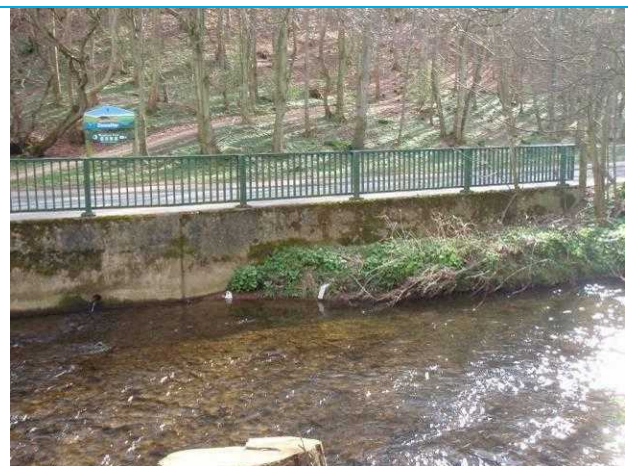
Photograph 4: Upstream end of wall.

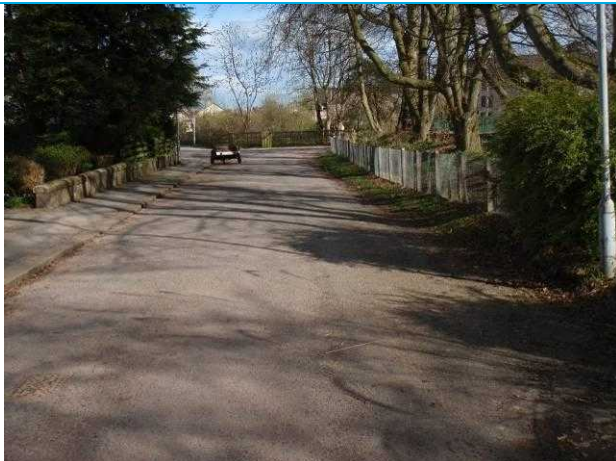
Photograph 1: Look along road at top of embankment.

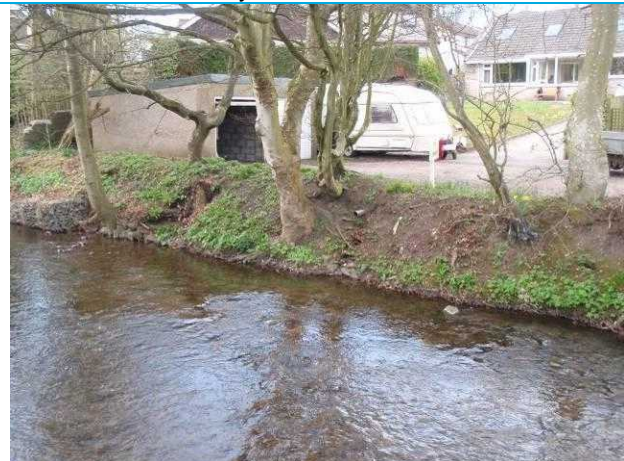
Photograph 2: Earth embankment with mature trees looks relatively stable.

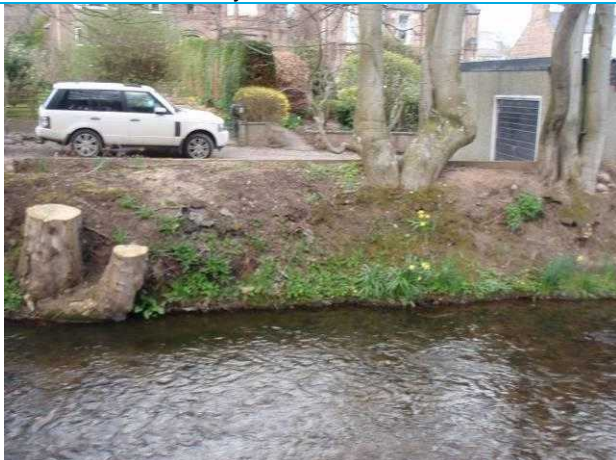
Photograph 3: Earth embankment with mature trees looks relatively stable.

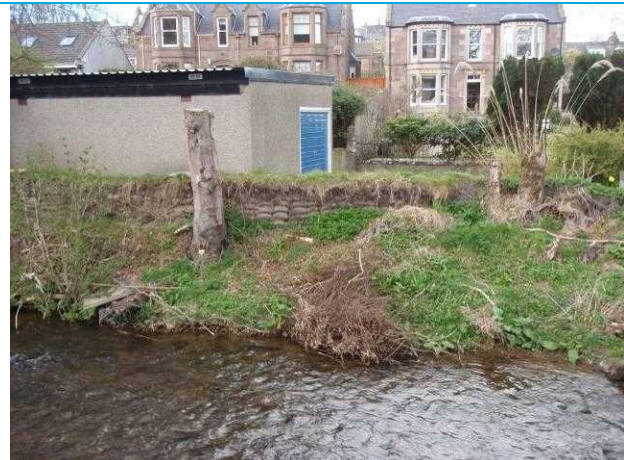
Photograph 4: Sandbag walls around garage.
